# Blind Spot Monitor DTC C1AC1 or C1AC2

**Service Category** Audio/Visual/Telematics

**Section** Park Assist/Monitoring

| YEAR(S) | MODEL(S) | ADDITIONAL INFORMATION |
|---|---|---|
| 2019 | Tacoma | |

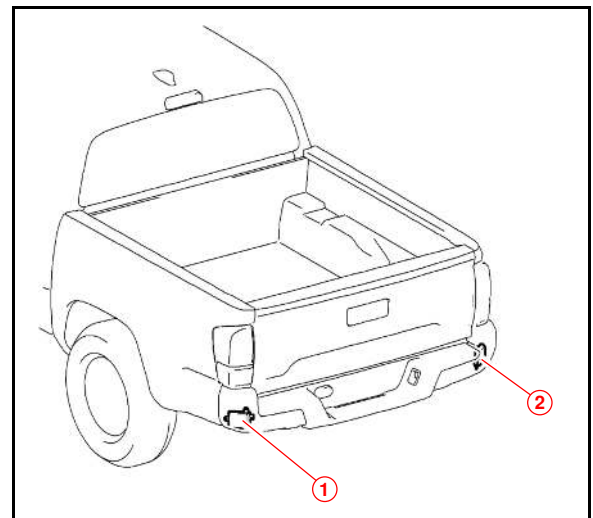
**Figure 1.**

| 1 | Blind Spot Monitor Sensor LH (Master) |
| 2 | Blind Spot Monitor Sensor RH (Slave) |

- B. Install the NEW Blind Spot Monitor sensors with the three nuts.

Torque nuts to 9.0 N\*m  
(92 kgf\*cm, 80 in\*lb)
