# Technical Service Bulletin

## 20 MIL on or difficulty refueling, DTC P045100, P044100, P202500, and/or P045300 stored in the ECM

20 20 25 2050276/5 February 12, 2020. Supersedes Technical Service Bulletin Group 20 number 19-24 dated December 18, 2019 for reasons listed below.

| Model(s) | Year | VIN Range | Vehicle-Specific Equipment |
|---|---|---|---|
| A6, A7 | 2016 - 2018 | All | 3.0T |

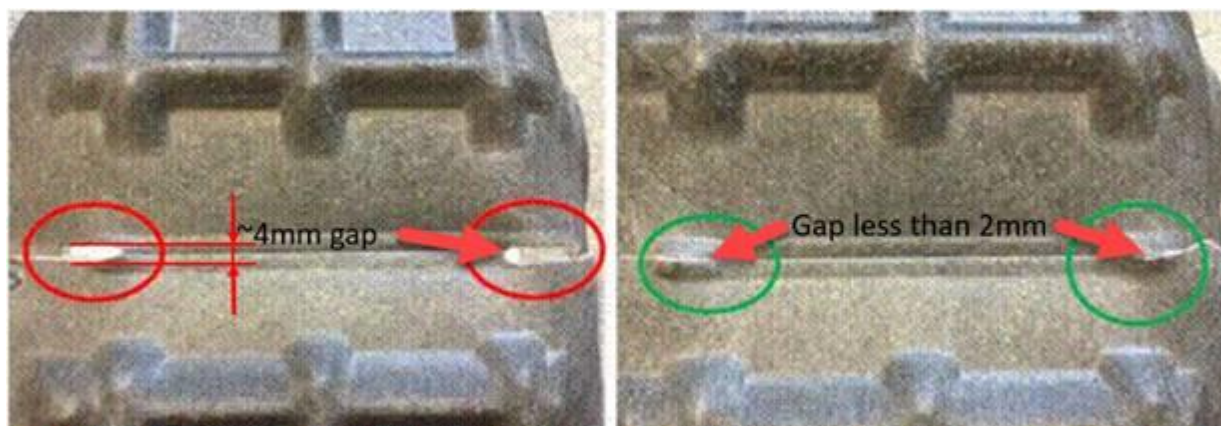
**Figure 1.** How to determine which steps to take Version 1 (~4mm gap) or Version 2 (gap less than 2mm).

### Version 1 (A6 only):

1. If the updated wheel liner has not yet been installed. Then install the updated wheel liner, which has closed slots around the NVLD filter.
  - Remove the EVAP canister, ventilation tube, and NVLD pressure switch.
  - Remove all components mounted on the EVAP canister.

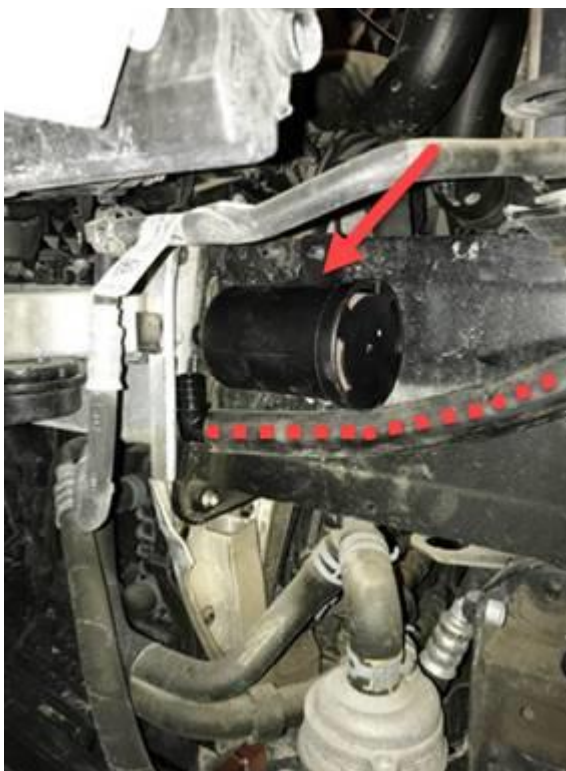
**Figure 3.** Installing the new NVLD filter.

1. Replace the EVAP canister only if weight is greater than 2650 grams.
  - Install a new J909.
  - Install the NVLD filter (new part number, Version 2) in the engine compartment on the left frame rail just in front of the ABS module, secure with M6 nut. (Figure 3).

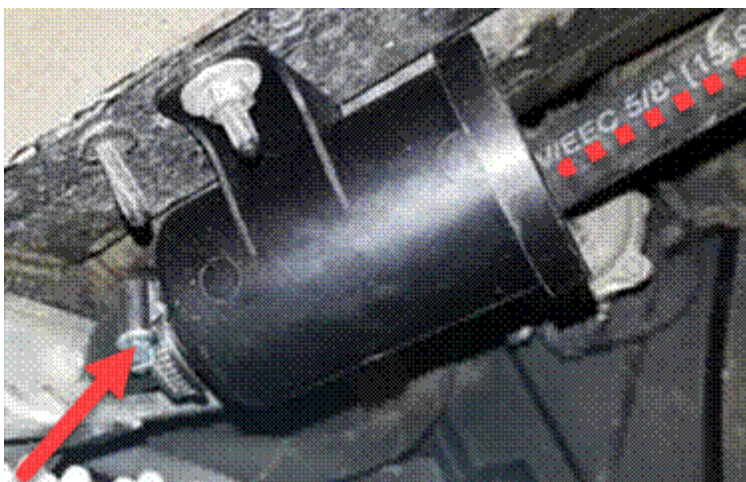
**Figure 4.** Connecting the NVLD filter.

2. Connect the filter to the 5/8" ID rubber hose via 1x plastic elbow and 1x rubber elbow (Figure 4).

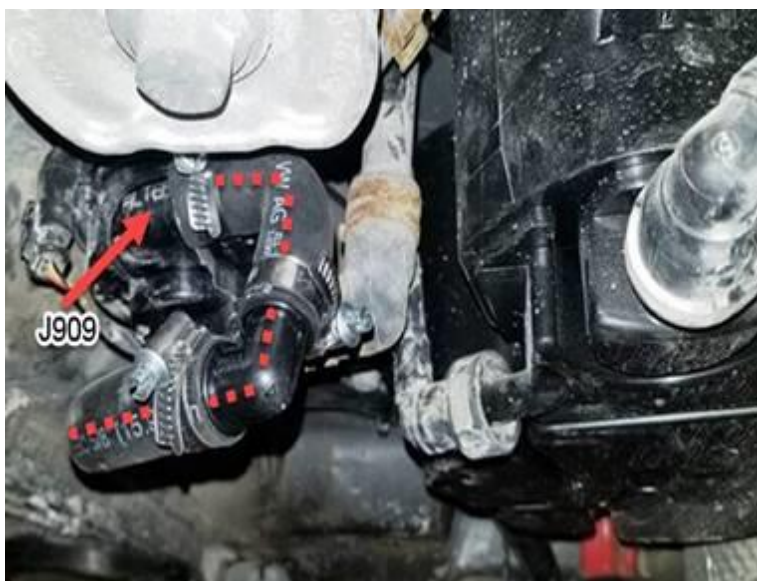
**Figure 9.** Closer look at the connections.

5. Before connecting 5/8" ID rubber hose to 90 degree connector, cut to length, as needed. Connection details to the J909 are shown in Figure 8 and 9.

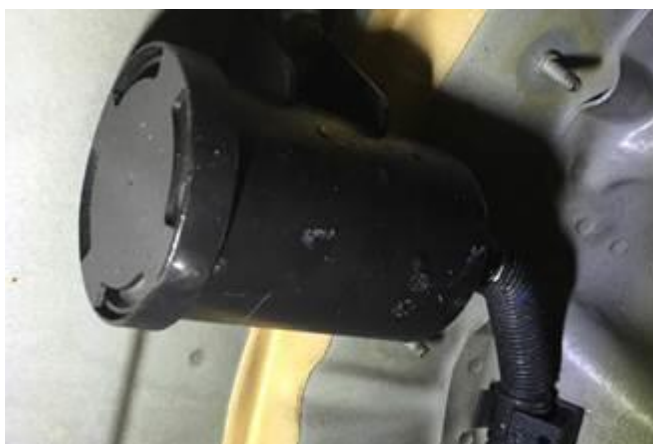
**Figure 10.** Remove original NVLD filter.

6. Remove original NVLD filter assembly. (Figure 10).
