# Technical Service Bulletin

| <b>Subject:</b><br><br><b>CHECK ENGINE LIGHT ON WITH DTCs P24C6:00, P24AE:00,<br/>P24B1:00 AND/OR P24AF:00</b> | <b>Bulletin No.:</b> 01-003/20 |
| | <b>Last Issued:</b> 02/13/2020 |

2018-2019 CX-5 SKYACTIV-D 2.2

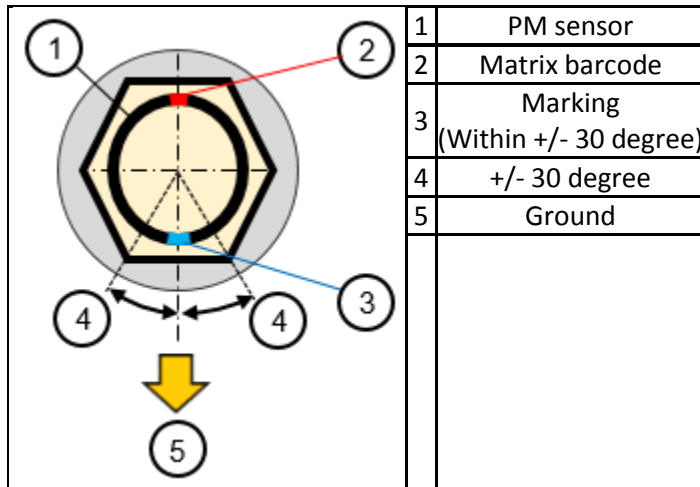
**PROPER ORIENTATION OF PARTICULATE MATTER (PM) SENSOR:**

**NOTE:** To reduce water accumulation in the PM sensor, follow the steps below when installing the sensor so the sensor element faces upward.

1. Find the matrix barcode (2) on the PM sensor (1) that faces the same direction as the sensor element (See "Location of matrix barcode" below).
2. Mark (3) the sensor body 180 degrees opposite of the matrix barcode and harness side of the free nut.
3. Install the PM sensor so that the marking faces downward to the ground (5)  $\pm$  30 degrees (4).

**NOTE:** When tightening the free nut, the sensor housing may turn together. For the best result, temporarily tighten the nut holding the sensor housing at 15 degrees before the target angle, then tighten to the specified torque.

- **Tightening torque: 30-44 ft-lbf {40-60 N·m, 4.1-6.1 kgf·m}**

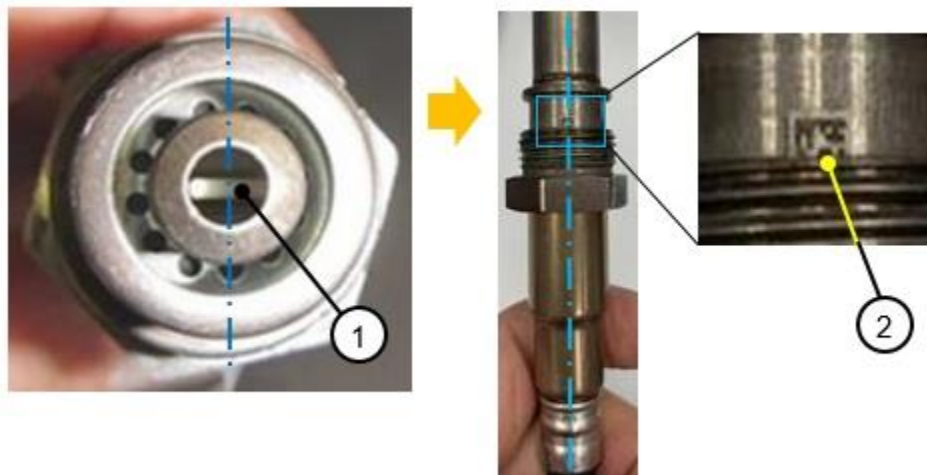
#### Location of the matrix barcode:

Locate the sensor element plate (1) and imagine the dashed line as shown below. The matrix barcode (2) is printed at the crossing of the line and either side of the sensor housing.

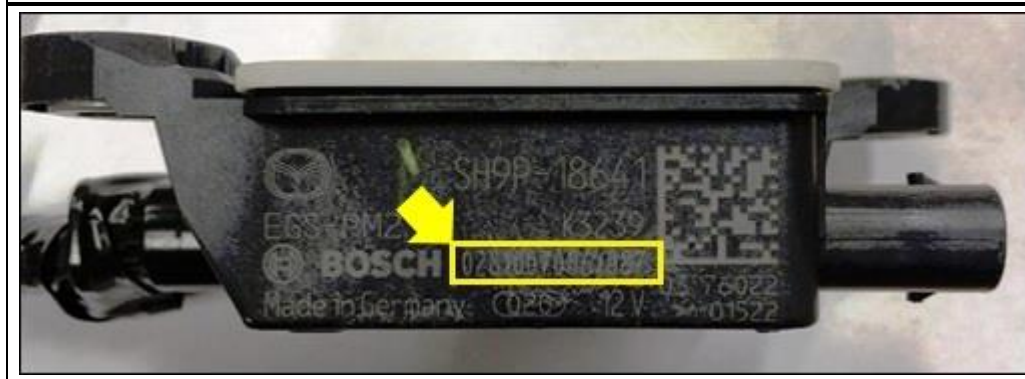
**NOTE:** If the modified parts kit listed in the table above is not available, an older parts kit (SHY6-18-7E0A) may be ok to use for this repair. Follow the sensor inspection instructions below to determine if the older kit can be used for this repair or not.

1. Inspect the ID Number (shown below) on the PM sensor from kit SH9P-18-641A.
2. Is the ID Number **0281007918/919** or greater?

- If No, the kit cannot be used in this repair.
- If Yes, the kit can be used in this repair.
