WT20-001

ITB20-003

February 10, 2020

## 2014-2020 Q50 AND 2017-2020 Q60; TPMS SENSOR LEAKING AIR

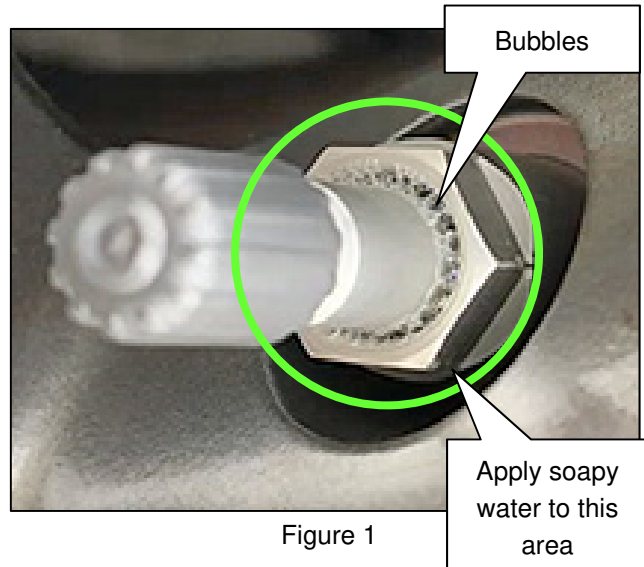
2. Apply a mixture of soap and water to the area shown in Figure 1.

3. Visually inspect for bubbles in the area between the valve stem and the valve nut.

- If bubbles were found in the area shown in Figure 1, proceed to step 4.
- If no bubbles were found, this bulletin does not apply. Further inspection may be necessary to locate a wheel/tire leak that is not covered by this bulletin.

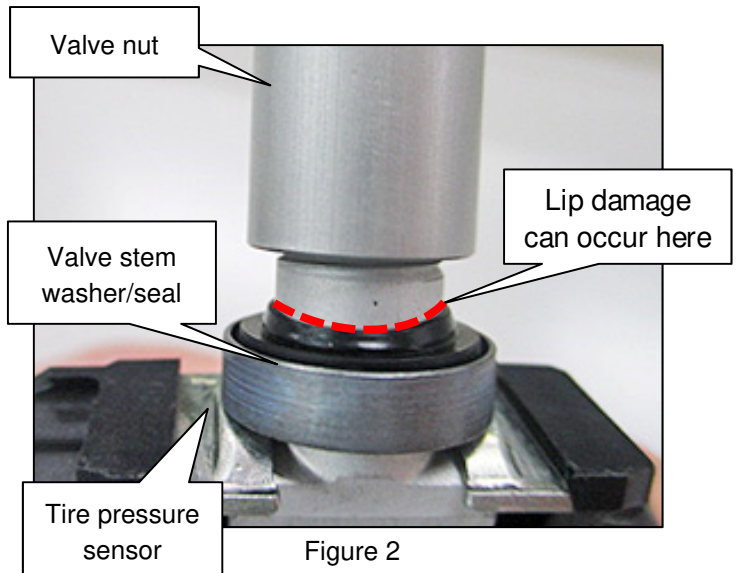
**NOTICE** Valve stem washer/seal lip damage may occur if the valve stem seal is not centered in the wheel. Take care to center the valve stem when installing into the wheel (see Figure 2).

5. Replace the valve stem washer/seal.

6. Reinstall the tire pressure sensor into the wheel with a new valve nut from the PARTS INFORMATION on page 3, and then torque to the new specification below.

- Valve nut torque: 10 N•m  $\pm$  0.5 (1.02 kg-m, 88.5 in-lb)
