| <b>HYUNDAI</b><br><b>Technical Service Bulletin</b> | GROUP<br><b>FUEL SYSTEM</b> | NUMBER<br><b>20-FL-001H</b> |
| | DATE<br><b>February, 2020</b> | MODEL(S)<br><b>ELANTRA (AD/ADA)</b> |
| <b>SUBJECT:</b> | DTC P0300/P0301/P0302/P0303/P0304 ECM SOFTWARE UPDATE AND IGNITION COIL INSPECTION/REPLACEMENT | |

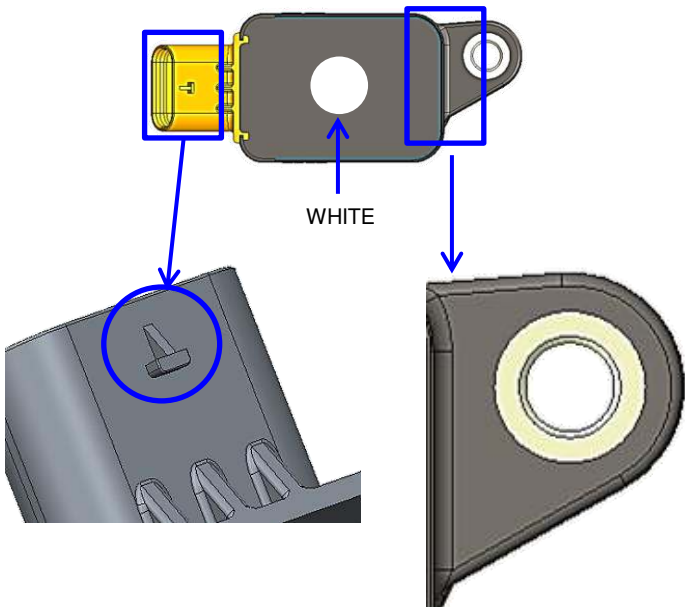
| Older Style Ignition coil with WHITE Mark | Older Style Ignition coil with BLUE/GREEN/GREY Mark |

| PART NAME | PART NUMBER | REMARKS |
|---|---|---|
| IGNITION COIL | 27300-2E601 <div style="display: flex; justify-content: space-around; align-items: center;"> <div style="text-align: center;"> <p><b>Older Style</b></p> <p>Replacement ignition coil with previous shaft design</p> </div> <div style="text-align: center;"> <p><b>Newer Style</b></p> <p>Replacement ignition coil with updated shaft design</p> </div> </div> | <ul style="list-style-type: none"> <li>Both the older and newer ignition coil shaft styles are interchangeable.</li> <li>Color marking inspection does not apply to the newer style ignition coil with updated shaft design.</li> <li>Replace if the vehicle ignition coil is the older style and has a WHITE or BLUE mark on top.</li> <li>Do not replace if the vehicle ignition coil is the older style and has a GREEN or GREY mark on top.</li> </ul> |
