## SERVICE BULLETIN

EC19-005a

NTB19-011a

### 2016 – 2019 TITAN XD; MIL ON WITH DTC P2048 STORED

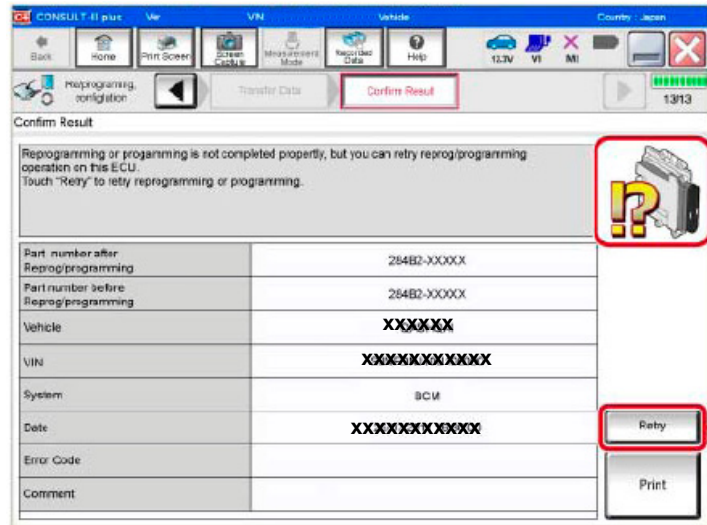
Figure 5

If reprogramming does not complete and the “!?” icon displays as shown in Figure 5:

- Check battery voltage (12.0 - 15.5 V).
- Ignition is ON, engine OFF.
- External Bluetooth® devices are OFF.
- All electrical loads are OFF.
- **Select retry and follow the on screen instructions.**
- **“Retry” may not go through on first attempt and can be selected more than once.**

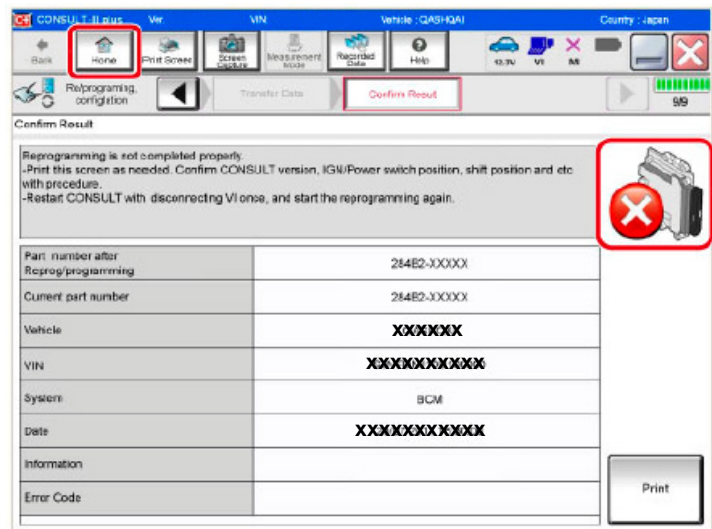
Figure 6

If reprogramming does not complete and the “X” icon displays as shown in Figure 6:

- Check battery voltage (12.0 - 15.5 V).
- CONSULT A/C adapter is plugged in.
- Ignition is ON, engine OFF.
- Transmission is in Park.
- All C-III plus / VI cables are securely connected.
- All C-III plus updates are installed.
- **Select Home, and restart the reprogram procedure from the beginning.**
