# Service Bulletin

Bulletin No.: 20-NA-021

Subject: Intermittent Service Steering Column Lock message displayed with U0155 Set

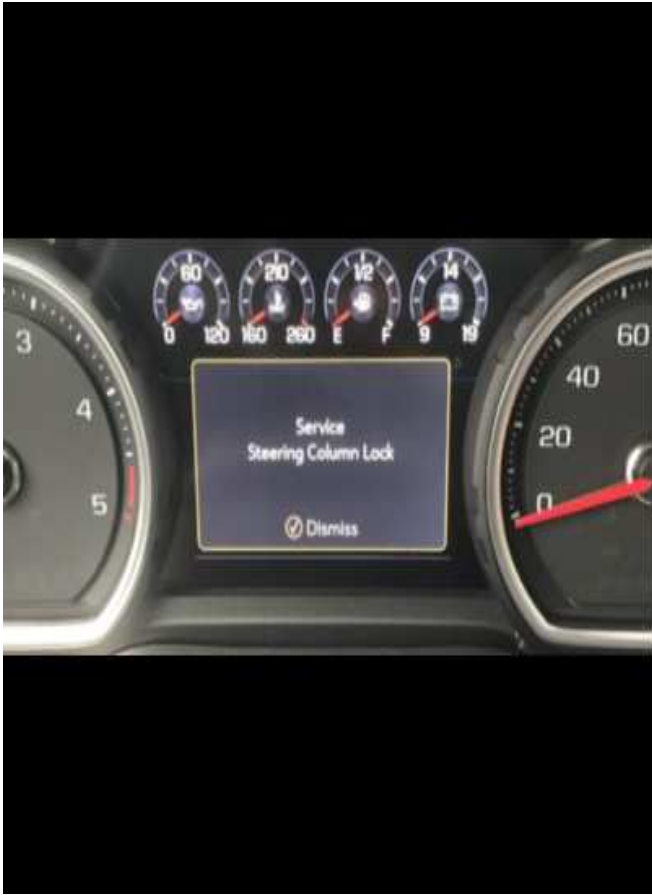
| Condition | <p>Some customers may comment on a "Service Steering Column Lock" message displaying that may clear when the engine is started. A technician may find DTC U0155 set/stored in vehicles history.</p> <p>" DTC U0155: Lost Communication with Instrument Cluster</p> <p style="text-align: right;">5500772</p> |
| Cause | The cause of the condition may be the program in the Steering Column Lock Module is not optimized to the wake up signals on the communication bus. |

| Correction | Reprogram the Steering Column Lock Module with the latest software, refer to K60 Steering Column Lock Module: Programming and Setup in SI. |
