# Service Alert

**i-ACTIVSENSE WARNING AND SBS INDICATOR LIGHTS ON WITH  
DTC B14F9:00 STORED UNDER HOT WEATHER CONDITIONS**

**Service Alert No.:** SA-042/20

2019-2020 Mazda3  
2020 CX-30

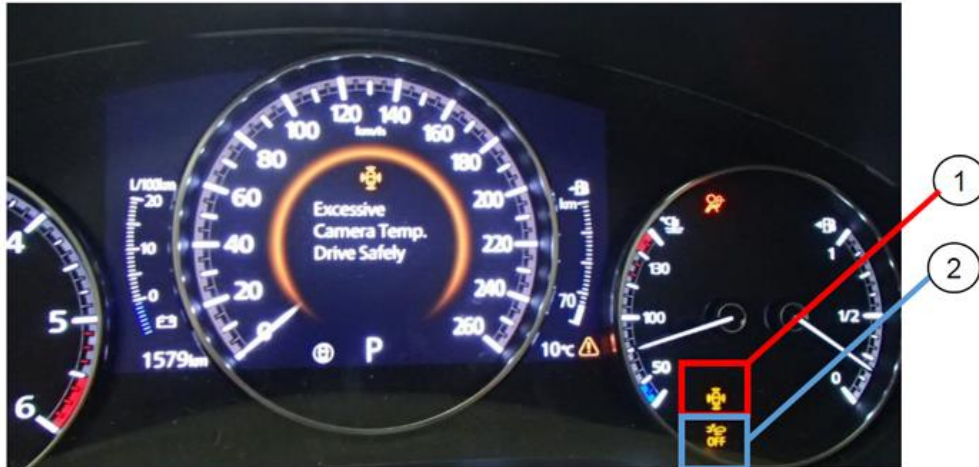
- i-ACTIVSENSE warning light ON (1)
- Smart Brake Support (SBS) indicator light ON (2)
- "Excessive Camera Temp. Drive Safely" or "Safety and Driver Support Systems Temporarily Disabled" warning messages
- DTC B14F9:00 stored in memory

DTC\_B14F9:00 is falsely stored instead of DTC B14F0:4B.

DTC\_B14F0:4B [VCM] (Forward sensing camera (FSC) internal temperature abnormality) - FSC detects temperature higher than operation range.

1. Verify customer concern.
2. Is DTC\_B14F9:00 stored in memory?
  - Yes - Go to MGSS DTC B14F0:4B [VEHICLE CONTROL MODULE]
  - No - This service information does not apply. Go to MGSS for normal diagnosis.
3. Contact Hotline for latest repair information.
4. Verify repair.
