# Technical Service Bulletin

## 01 MIL on, DTC P218100, P017B00, P308100, and/or P01E400 are stored in the ECM

01 20 57 2058767/3 April 10, 2020. Supersedes Technical Service Bulletin Group 01 number 20-52 dated March 26, 2020 for reasons listed below.

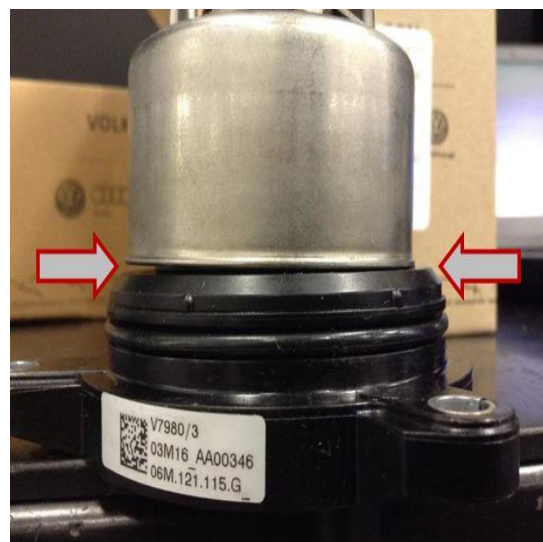
1. Remove the thermostat and check whether it closes completely. If the coolant is still warm, put the thermostat in cold water to restore its original condition. If there is a gap between chamber and seal, the thermostat is faulty and needs to be replaced.
2. Attach photos to the repair order which clearly shows that the thermostat does not close neatly.

**Figure 1.** Gap between chamber and seal.

After the repair, fill with G12evo coolant in the coolant circuit.
