# Technical Service Bulletin

**Subject:**

MIL ON WITH DTCs P1285, P1299, P0128, P0300, P0301, P0302,  
P0303, P0304, P0316

**Bulletin No.:** 01-005/20

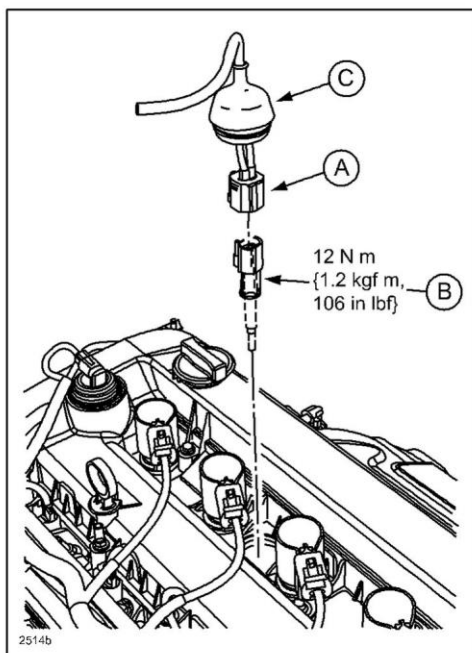
Engine temperature concerns may be due to corrosion at connector 0140-119 (A). Refer to MGSS online (CONTROL SYSTEM - 2.5L).

1. Inspect the cam cover trough, making sure it is clear of debris like leaves, wasps, dirt and the drain hole by cylinder 4 is open.

2. Inspect connector 0140-119 (A) at cylinder head temperature (CHT) sensor (B) for evidence of water contamination.

3. If corrosion from water contamination is severe and terminals are rusted and disintegrated:

a. Cut off connector 0140-119 (A) and install a new pigtail connector. Refer to instruction sheet.

b. Replace the CHT sensor (B). Refer to MGSS online (CYLINDER HEAD TEMPERATURE (CHT) SENSOR REMOVAL/INSTALLATION - 2.5L).

**NOTE:** If corrosion is not severe, remove any water and thoroughly clean connector 0140-119 (A) and the CHT sensor (B)
