# Service Alert

**"IN-VEHICLE NETWORK MALFUNCTION" INSTRUMENT CLUSTER  
WARNING MESSAGE**

**Service Alert No.:** SA-029/20

2019-2020 Mazda3

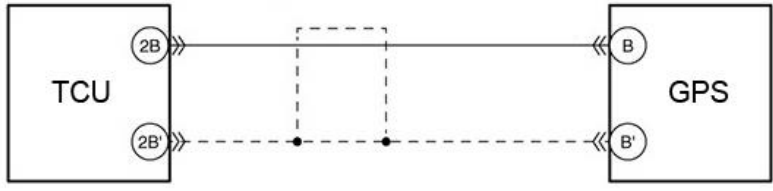
| DTC | Action |
|---|---|
| B119F:01 | <p>1. Check GPS antenna connection.</p> <p>1. GPS connection is good - No further repairs needed. TSB repair is coming soon.<br/> <b>Inform the customer that Mazda is aware of the issue and is working on a repair.</b><br/> <b>Release the vehicle to the customer.</b></p> <p>2. GPS connection is bad - Repair GPS antenna connection.</p> |

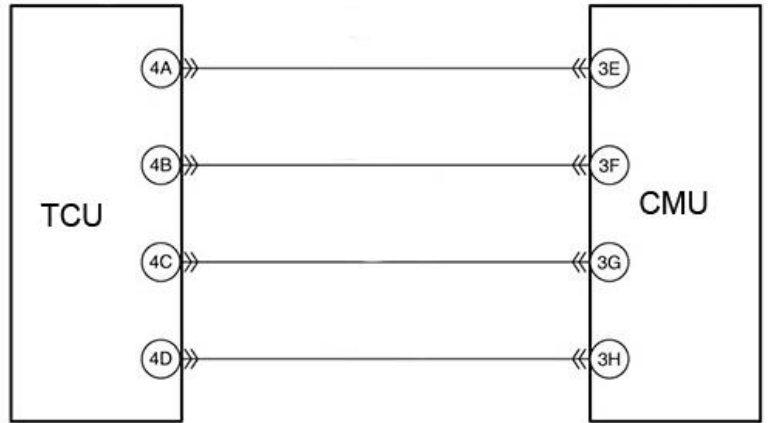
| DTC | Action |
|---|---|
| B1252:87 | <p>1. Check USB cable connections between TCU and CMU.</p> |

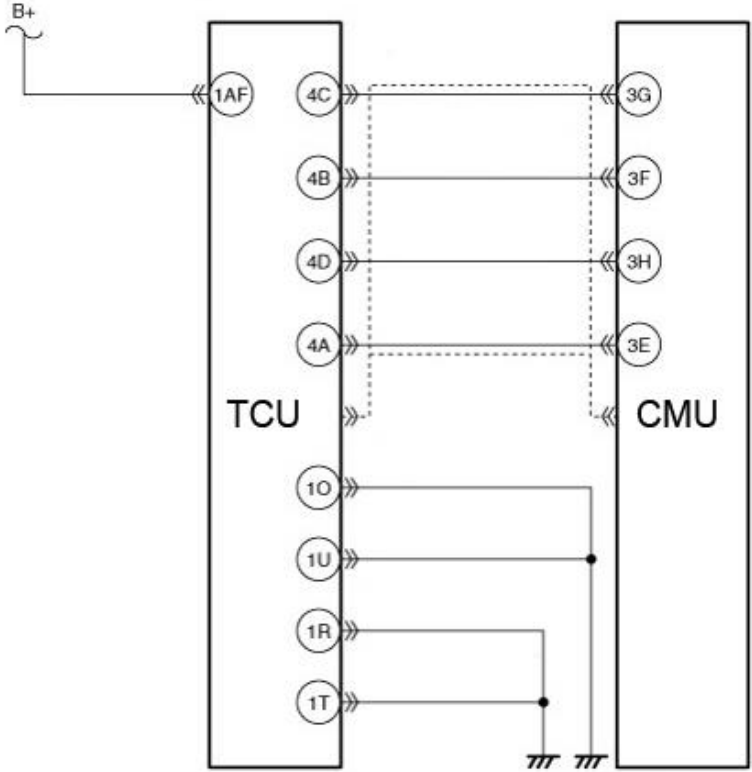
| U0198:00 | <p>1. Check USB cable connections between TCU and CMU.</p> |
