## STAR ONLINE PUBLICATION

**Case Number:** S2008000076

**Symptom/Vehicle Issue:** Exhaust Manifold Heat Shield Rub Through Of MDS Solenoid Wiring. P3449, P3441, P3425, And P3401 May Be Set In The PCM

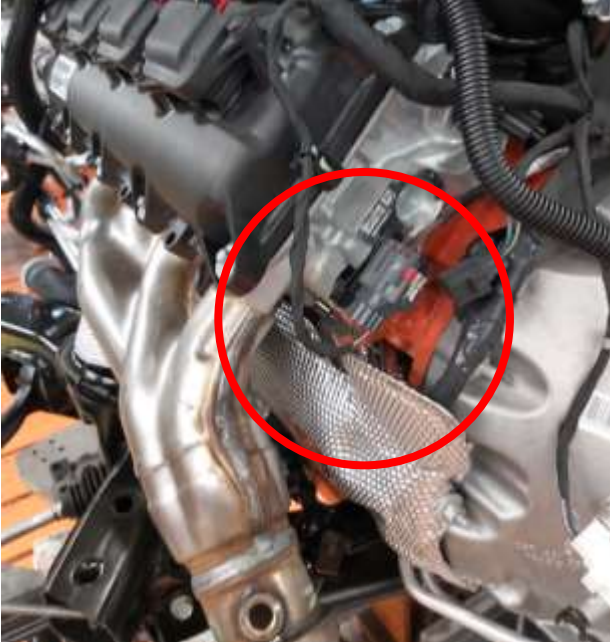
**Rear of driver's side cylinder head**

**Discussion:** The heat shield for the driver's side exhaust manifold can easily deform during assembly or repair. The heat shield is known to deform in such a way that it contacts the MDS solenoid wiring harness located at the rear of the driver's cylinder head.

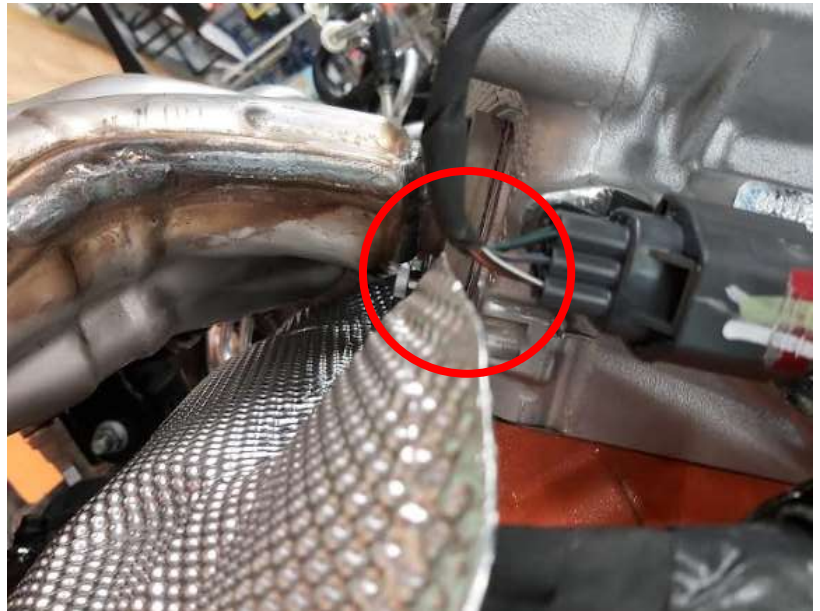
**Wiring rub through point**

**Repair:** If there is less than 15mm of clearance. Obtain the desired clearance by bending or cutting away the heat shield from the wiring harness. Repair any wiring harness chaffing damage found.
