# Technical Service Bulletin

## 91 SOS warning displayed in instrument cluster, DTCs B105313 and B153313 stored in the data bus diagnostic interface

91 20 79 2054630/2 June 19, 2020. Supersedes Technical Service Bulletin Group 91 number 19-55 dated April 25, 2019 for reasons listed below.

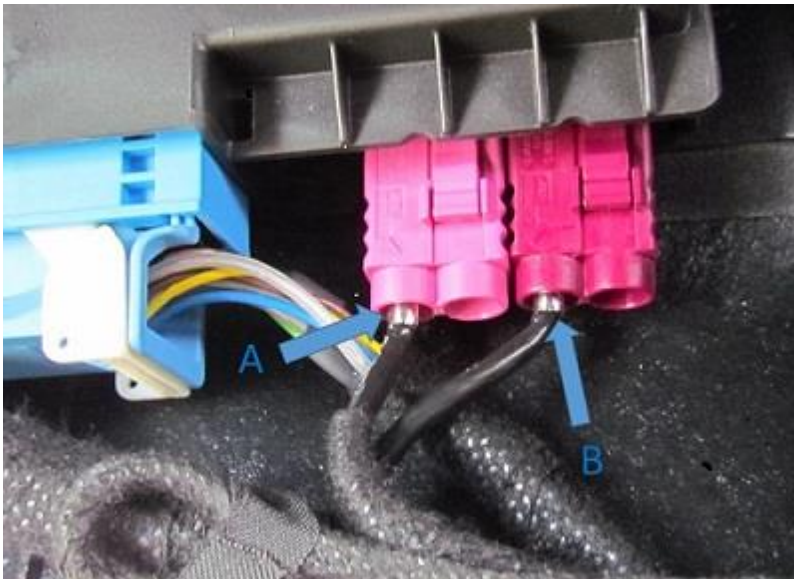
Poor contact at one of the coaxial wiring's FAKRA connections between data bus on board diagnostic interface, J533 (address word 0019) and one of the external antenna's for emergency call services.

| DTC Reference Table | | | |
|---|---|---|---|
| B105313<br>GSM antenna Open circuit | Antenna for telephone<br>status<br>0x24E2 | A | IW3<br>IW5 + 4GR<br>IW5 + 4GY |

| B153313<br>GSM antenna 2 Open circuit | Status of antenna 2 for<br>phone<br>0x1836 | B | IW3<br>IW5 |

**Figure 1.** GSM antenna location reference at the data bus on board diagnostic interface, J533 (address word 0019).

Inspect connection at the data bus on board diagnostic interface, J533 (address word 0019):

1. Perform a visual inspection of the cable and connector.

Replace the contact utilizing the VAS 6720 if:

- There is tension on the cable. The cable should have some slack.
- The pin is bent or cracked.
- The cable is bent or damaged.
- The connector is not fully connected.

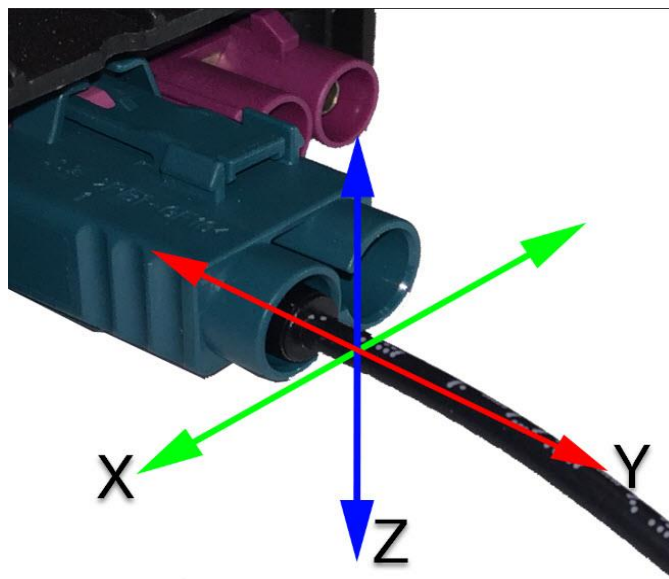
**Figure 2.** Coaxial cable X, Y, and Z axis.

## 2. Perform a function check of the cable connector:

- View the applicable measured value from the overview table above.
- Lightly pull, or push the applicable coaxial cable along its respective X, Y, and Z axis (Figure 2).
- As the fault detection is not real time, hold the cable in each position for 5 seconds and observe the measured value (Figure 3).

## 3. If a fault is detected during step 2 (“Open Circuit”), replace the contact on the wire harness at the data bus on board diagnostic interface, J533 (address word 0019) utilizing the VAS 6720.
