# Service Alert

**"IN-VEHICLE NETWORK MALFUNCTION" INSTRUMENT CLUSTER  
WARNING MESSAGE**

**Service Alert No.:** SA-029/20

2019-2020 Mazda3

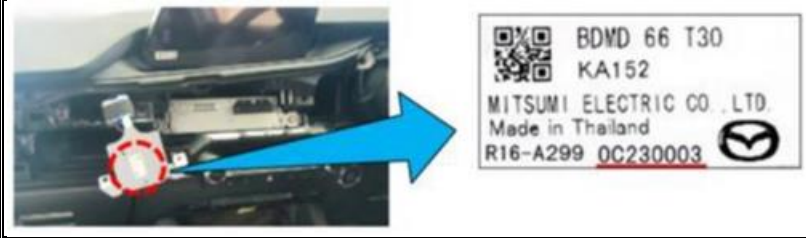
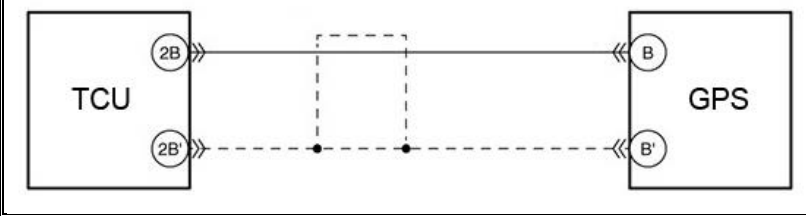
| DTC | Action |
|---|---|
| B119F:01 | <p>1. Check GPS antenna lot number. Is the lot number before 0C230003?</p> <ol style="list-style-type: none"> <li>1. Yes - Contact Hotline for the latest repair information.</li> <li>2. No - Go to next step.</li> </ol> <p><b>How to read lot number</b></p> <p>The lot number is in YMDDnnnn format. If it is 0C230003 or later, the part is already modified. No part number change for new modification.</p> <p><b>Example:</b></p> <p>0C230003: 0→2020 (year), C → March, 23→ 23th (day), 0003→serial number for the day</p> <p>9H161360: 9→2019 (year), H → August, 16→ 16th (day), 1360→serial number for the day</p> <p>2. Check GPS antenna connection.</p> <ol style="list-style-type: none"> <li>1. GPS connection is good - Refer to MGSS DTC B119F:01 [TELEMATICS COMMUNICATION UNIT]</li> <li>2. GPS connection is bad - Repair GPS antenna connection.</li> </ol> |

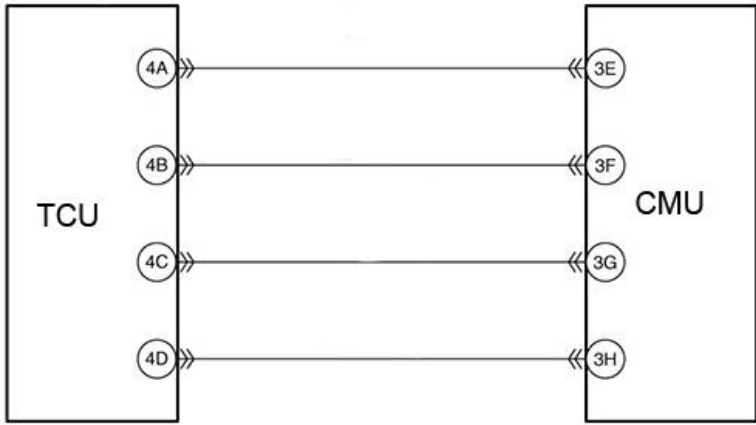
| DTC | Action |
|---|---|
| B1252:87 | 1. Check USB cable connections between TCU and CMU. |

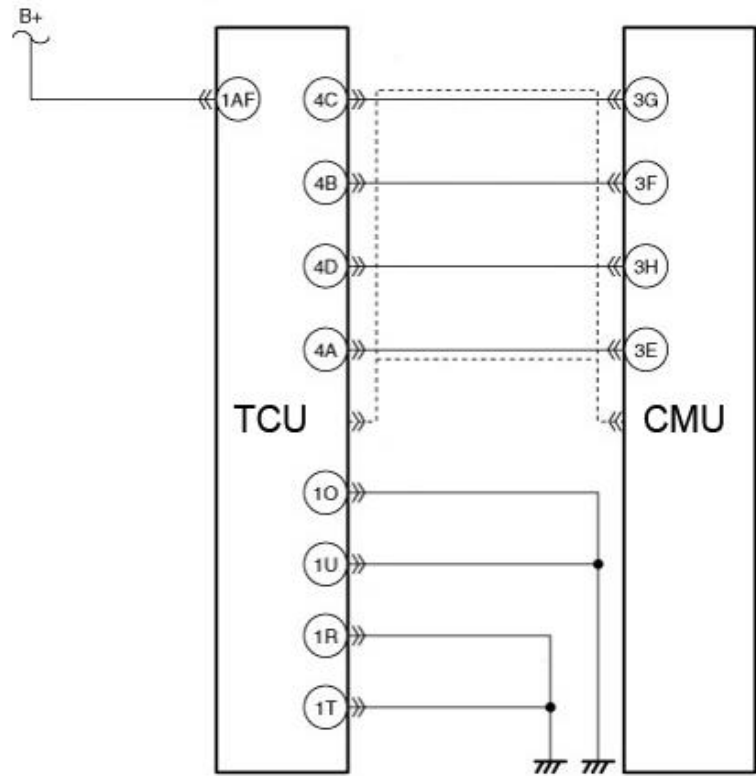
| U0198:00 | <p>1. Check USB cable connections between TCU and CMU.</p> |

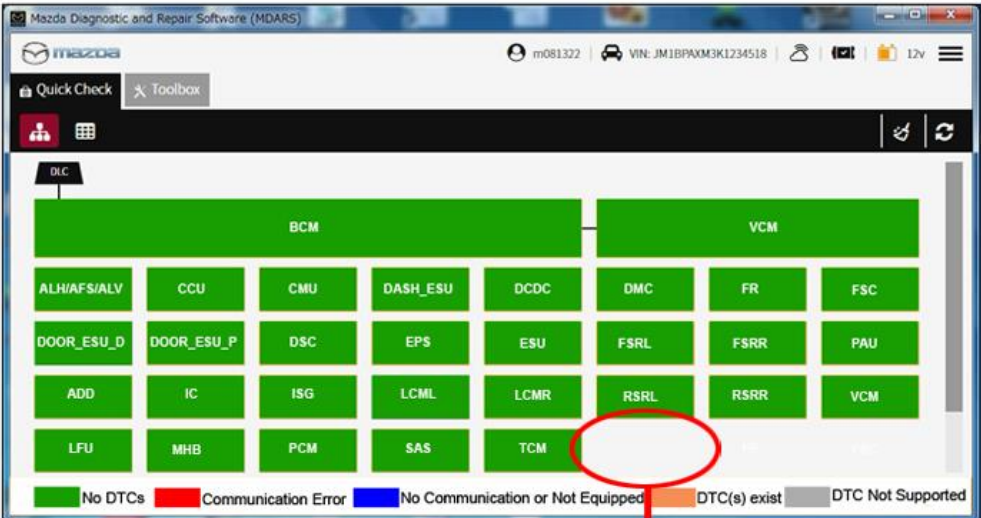
| a. | ID vehicle using MDARS. | |
