# Service Alert

**"IN-VEHICLE NETWORK MALFUNCTION" INSTRUMENT CLUSTER  
WARNING MESSAGE**

**Service Alert No.:** SA-029/20

**Last Issued:** 06/29/2020

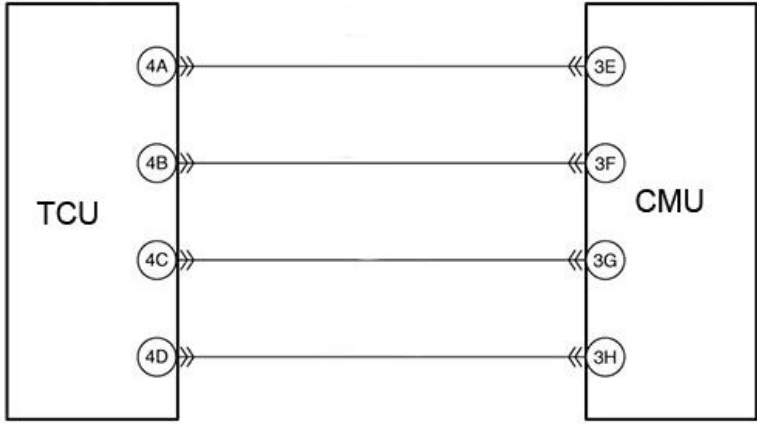
| DTC | Action |
|---|---|
| B1252:87 | 1. Check USB cable connections between TCU and CMU.<br> |

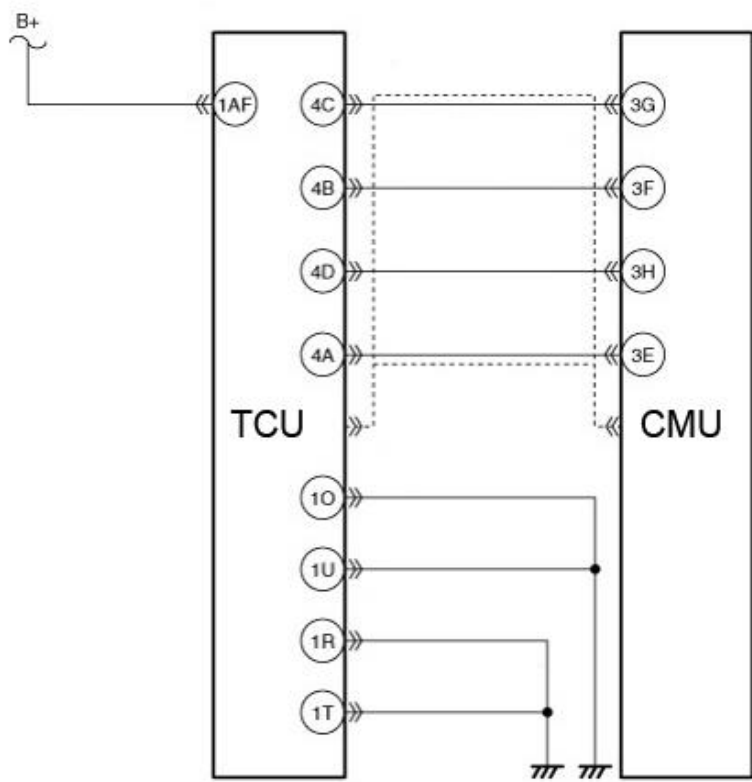
| U0198:00 | <p>1. Check USB cable connections between TCU and CMU.</p> |

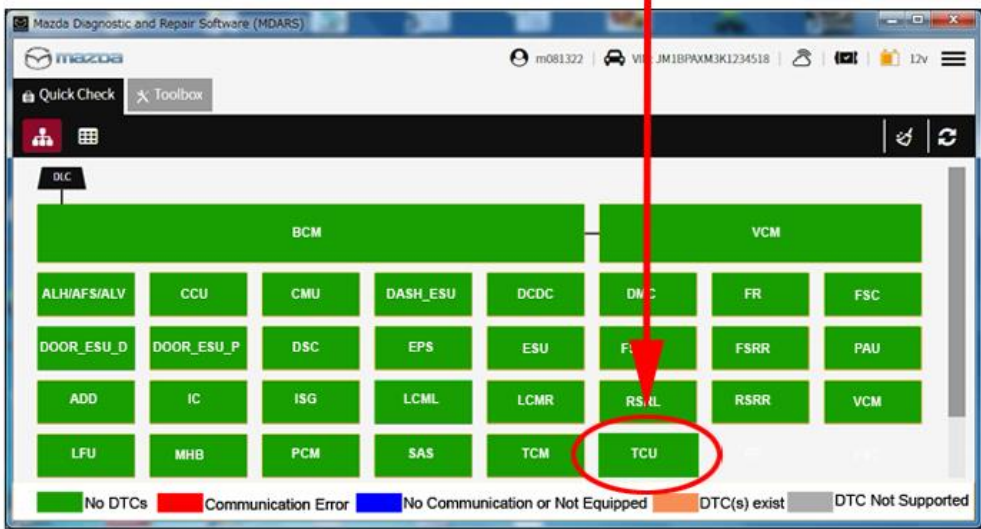
| e. | TCU now appears. Go to step 3. | |

TCU appears
