## SERVICE BULLETIN

| EC16-034c | NTB17-082c | June 29, 2020 |

### DTC P0456 CAUSED BY EVAP LEAK AT VENT CONTROL VALVE O-RING

**APPLIED VEHICLES:** All model year 2008 and newer Nissan vehicles  
except LEAF and Titan XD with V8 diesel engine

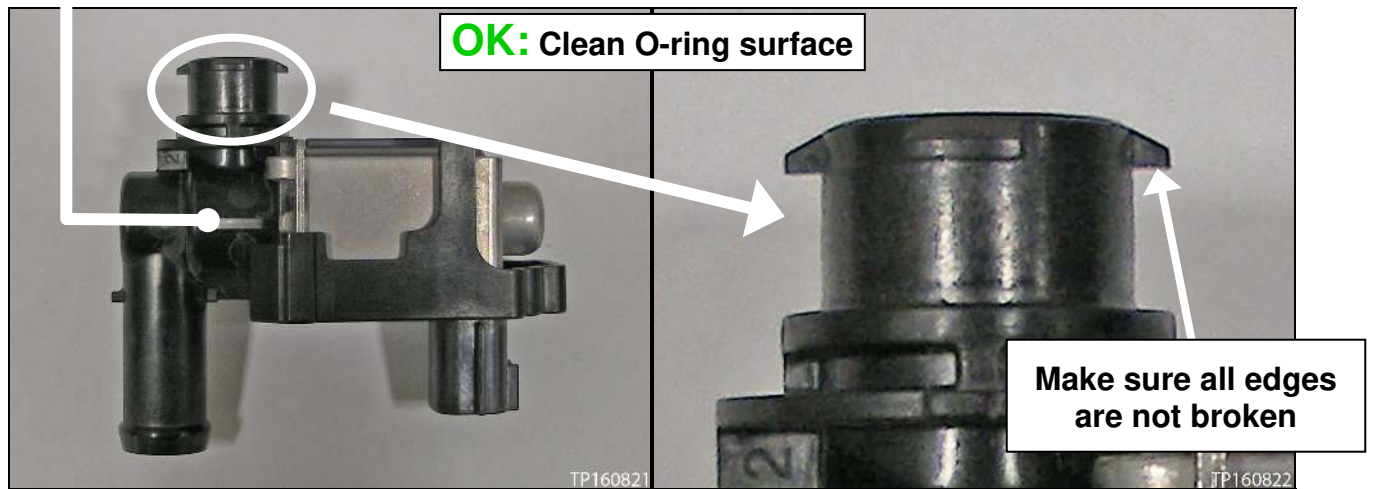
Figure 3

Where vent control valve  
mounts in canister

This surface must  
be clean all around

- Make sure the surfaces that the O-ring comes in contact with are clean.
- When installed, make sure the O-ring is not twisted or rolled over.
- Verify the repair is complete by checking for leaks with a “smoke” leak detection machine or CONSULT-III plus (C-III plus).
  - If a “smoke” leak detection machine is used, follow the manufacturer’s operating instructions.
  - If C-III plus is used:
    1. Confirm the fuel filler cap is secure.
      - Vehicles **with** a service port see page 5.
      - Vehicles **without** a service port see page 6.
    2. Using Active Test, close the vent control valve.
    3. Apply pressure using J-42909 until the bar graph reaches about halfway.
    4. Monitor the bar graph for 10 minutes.

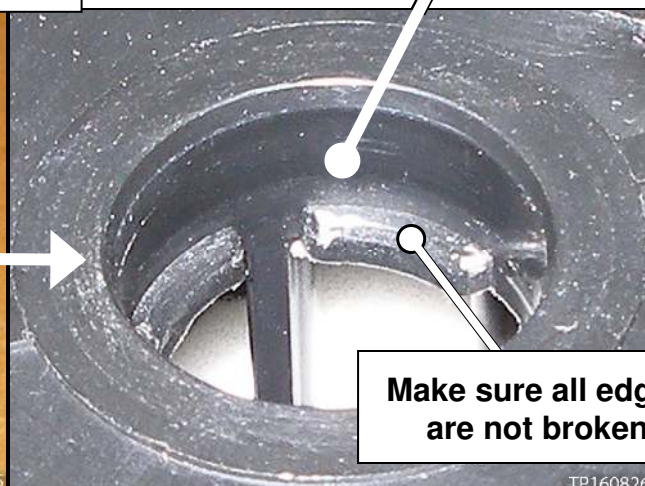
Figure 6

When fully seated  
(no gaps), O-ring  
is not twisted or  
rolled over

No gap all  
around
