# Technical Service Bulletin

## 91 Trunk lid taillight does not work or flickers, DTC B16D5F1, B16D5F2, B16D5F6, and/or B16D7F1, B16D7F2, B16D7F6 stored

91 20 86 2058647/2 July 14, 2020. Supersedes Technical Service Bulletin Group 91 number 20-42 dated March 2, 2020 for reasons listed below.

| Model(s) | Year | VIN Range | Vehicle-Specific Equipment |
|---|---|---|---|
| Audi e-tron quattro | 2019 | 000001 – 025632 | Not Applicable |

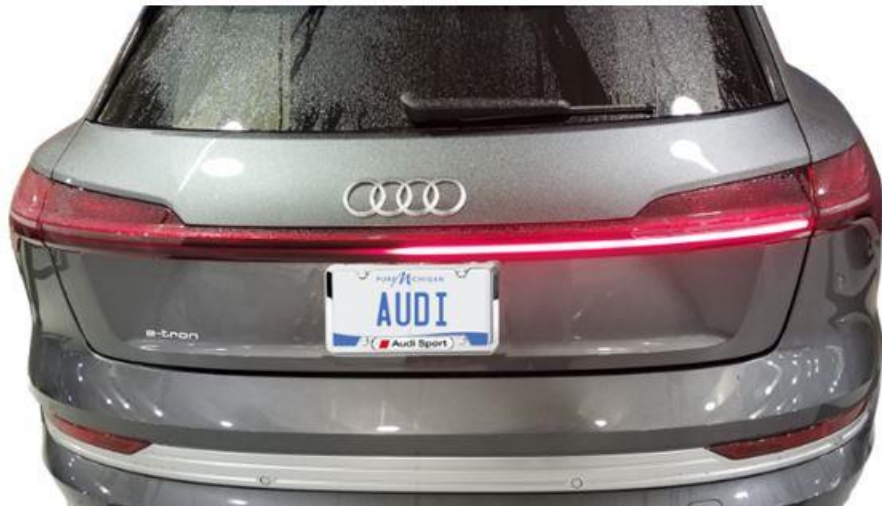
High resistance may form between the printed circuit board and LED contact points within the trunk lid taillight.

This can cause the light to flicker or only be partially lit (Figure 1).

**Figure 1.** Partially lit trunk lid taillight.

1. Attempt to duplicate the customer concern and compare faults to the workshop findings section of this TSB.
2. If the customer concern and/or the faults match, replace the center taillight. Ensure the GFF log is uploaded to GFF paperless.
