Subject: N202299080 - Special Coverage  
Camshaft Cover Replacement

Models: 2014 Buick Encore  
2011-2014 Chevrolet Cruze  
2012-2014 Chevrolet Sonic  
2014 Chevrolet TRAX

## N202299080 Camshaft Cover Replacement

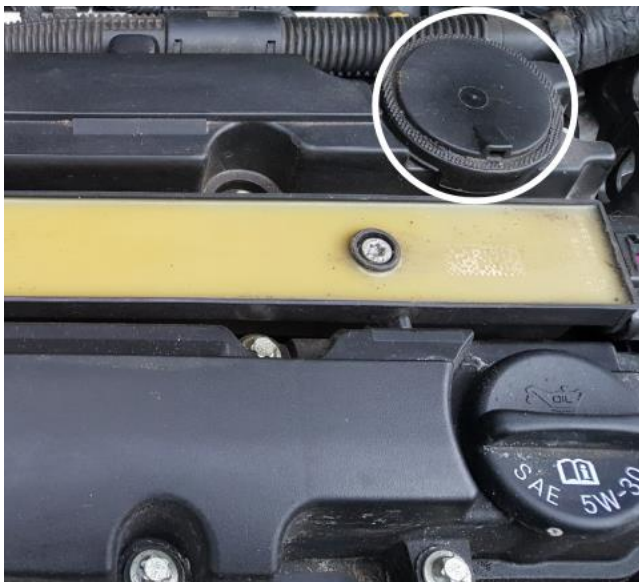
5354610

- c. With the engine running, listen for noise coming from the PCV valve, shown above. If noise is heard, check to see if the noise gets quieter or disappears with the engine oil dipstick removed.
- d. Reinsert the dipstick.

- e. Check to see if there is vacuum at the PCV vent at the front of the PCV valve by placing a piece of tissue near it. The tissue will be sucked against the vent and held if vacuum is present.
  - If the PCV valve is making noise and there is vacuum present at the PCV valve vent, replace the Camshaft Cover. Refer to *Camshaft Cover Replacement* in SI.
  - If the PCV valve does NOT make noise or leak vacuum, no further diagnosis or repair is covered under this special coverage. Claim diagnostic time and inform the customer that any further diagnostics or repair will have to be covered by customer pay, warranty, or good will.
3. Reinstall the engine cover. Refer to *Engine Cover Replacement* in SI.
