# Technical Service Bulletin

01 MIL on (rpm is restricted to 2500rpm), DTCs P191B00, P10EF00, and/or P048000 are stored in the ECM

01 20 74 2059449/1 August 5, 2020.

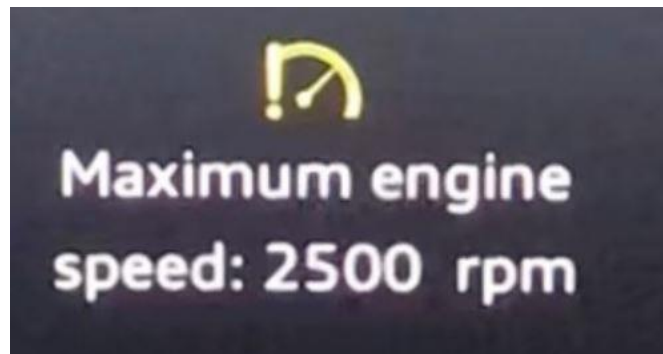
- MIL on.
- A maximum engine speed message appears in the instrument cluster (Figure 1).
- The vehicle may experience reduced engine performance.

*Figure 1. Message in the instrument cluster.*

A poor electrical connection to the cooling fan (radiator fan V7) is suspected, such as connector not seated, loose terminal, etc.

Please thoroughly inspect the connector for the radiator fan V7. Check for any connection issues, for instance, if the connector is not correctly seated, a loose or damaged terminal, etc.
