# MIL ON With DTC P0300 and/or Cold Start Misfire

**Service Category** Engine/Hybrid System

**Section** Engine Control

| YEAR(S) | MODEL(S) | ADDITIONAL INFORMATION |
|---|---|---|
| 2017 - 2020 | 86 | |

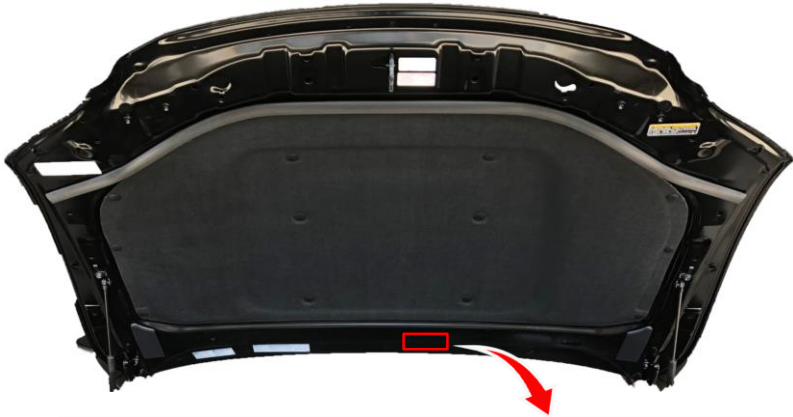
Figure 1. Location of Authorized Modifications Label on 2017 – 2020 86

2. Check for the Authorized Modifications Label affixed to the vehicle in the location shown below. Confirm if the Engine ECU calibration has been updated.  
Is the calibration ID listed the latest Engine ECU calibration?
  - **YES** — This bulletin does NOT apply. Continue diagnosis using the applicable Repair Manual.
  - **NO** — Continue to step 3.

4. Prepare and install the Authorized Modifications Label.
  - A. Using a permanent marker, enter the following information on the label:
    - Engine ECU part number [Refer to the **Parts Information** section for the **NEW PART NUMBER**]
    - Calibration ID(s) [Refer to the **Calibration Information** section for the **NEW CALIBRATION ID**]
    - Dealer Code
    - Repair Date
    - Change Authority [**This bulletin number**]
  - B. Affix the Authorized Modifications Label to the vehicle at the location shown in Figure 1. The Authorized Modifications Label is available through the MDC, P/N 00451-00001-LBL.
5. If possible, test-drive the vehicle from cold start at 50°F (10°C) to confirm the condition is no longer present.
