# Technical Service Bulletin

**VARIOUS ELECTRICAL SYSTEM MALFUNCTION(S) RELATED TO C-15 CONNECTOR CORROSION**

**Bulletin No.:** 09-026/20

2013-2015 CX-5 vehicles with VINs lower than JM3KE\*\*\*\*\*554564 (produced before Nov. 24, 2014)

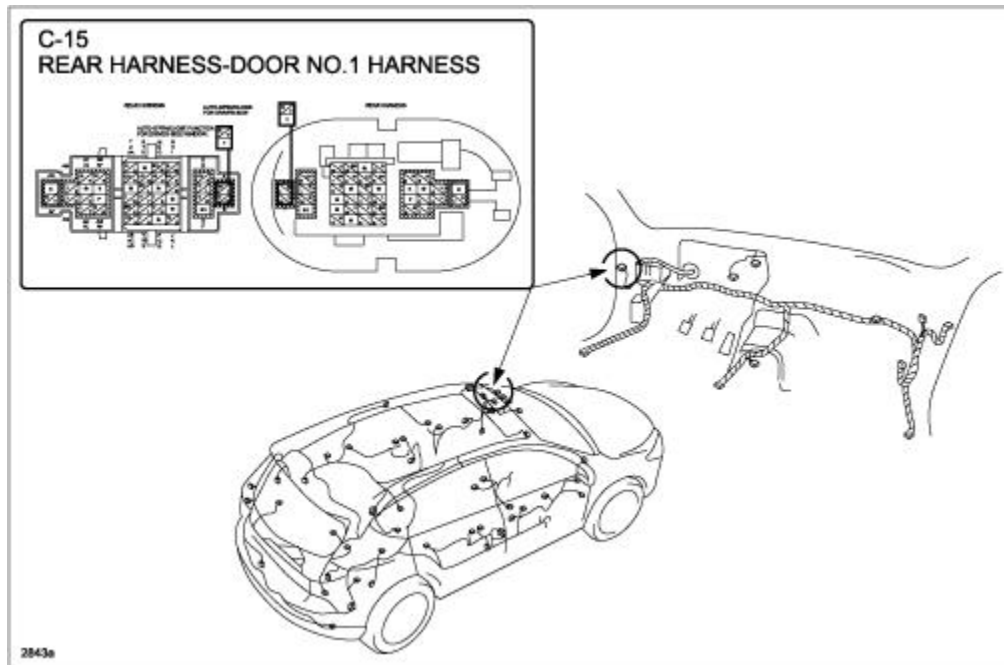
The symptoms listed above may be caused by corrosion of the C-15 connector terminals due to water intrusion through the front door. In low ambient temperatures, the door harness hardens. If the door is fully opened, it may create a gap between the door and the door harness grommet, which may allow water to enter through the gap.

- The front door harness grommet has been changed to improve sealing performance.
- Holes inside the front pillar (which are made for weight reduction), have been covered to prevent water intrusion.
- The C-15 connector has been improved.

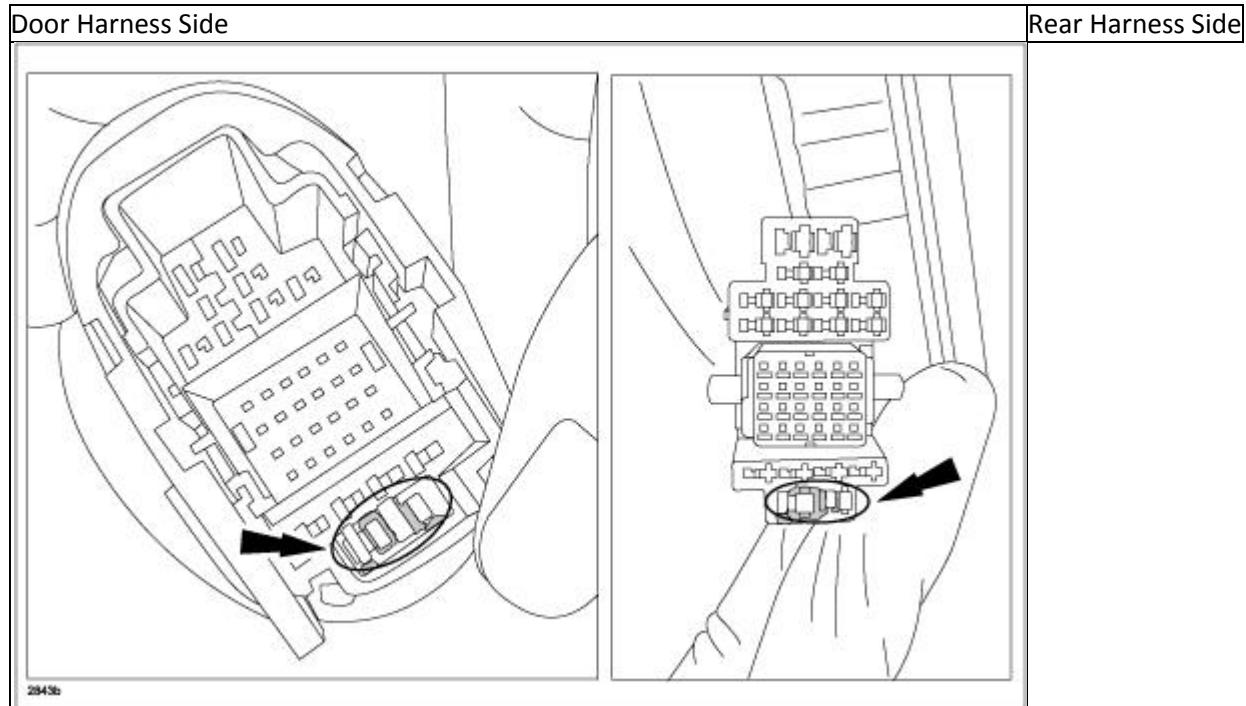
1. Verify the customer concern.
2. Record customers pre-set radio stations.
3. Slide the driver side front seat fully backwards.
4. Disconnect the negative battery cable.
5. Disconnect the C-15 connector according to the MGSS online instructions (FRONT DOOR REMOVAL/INSTALLATION).
6. Inspect for any corrosion found on the terminals shown below.

- If there is any corrosion found on the terminals, go to next step.
- If there is no corrosion found on the terminals, this bulletin is not applicable. Troubleshoot the concern(s) according to the MGSS online instructions.
