# Technical product information

| <b>Topic</b> | New Continental GT / GTC - Exhaust Flap - Diagnostic Trouble Code |
| <b>Brand</b> | Bentley |
| <b>Transaction No.</b> | 2060432/1 |

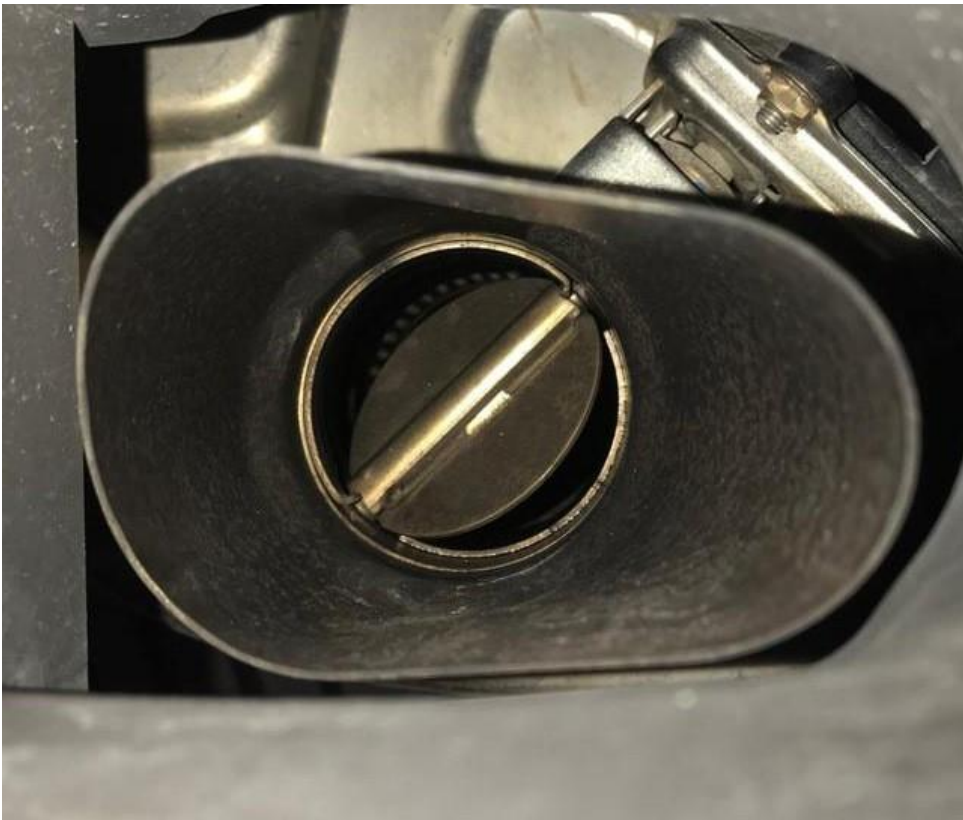
Figure 1.

If an Exhaust Flap is stuck in an open, closed, partially closed position or does not achieve a full range of motion continue to follow the instructions within this Technical Product Information (TPI) document – figure 1.

Remove the suspected Exhaust Flap Control Unit – Refer to *Repair Group. 26 Exhaust system – Exhaust flap control units (J883, 945) – To remove and fit.*

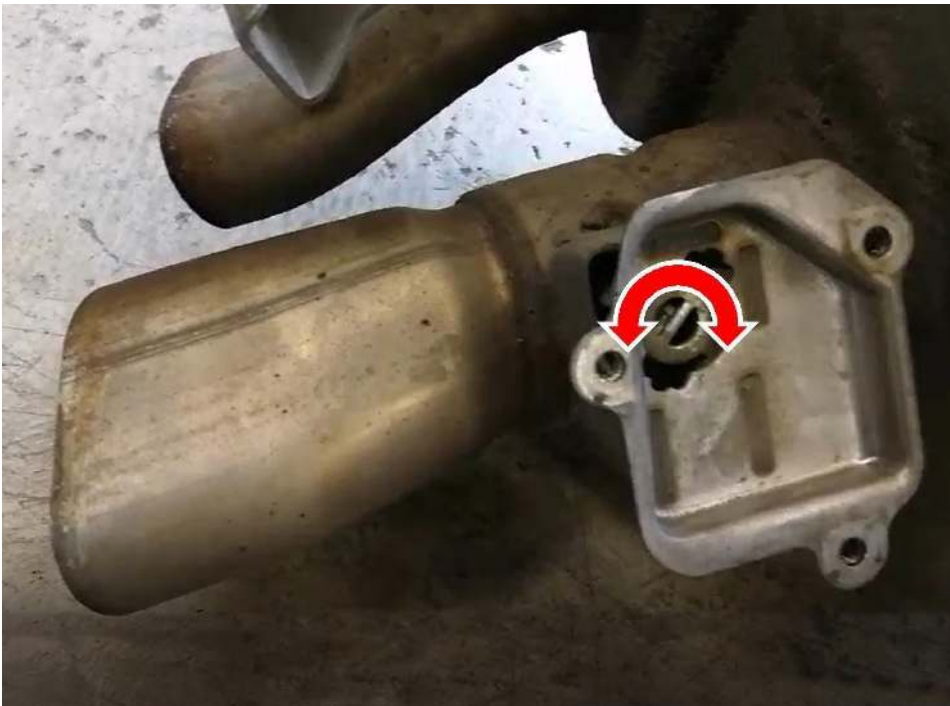
Check and confirm the Exhaust Flap spindle is free to open and close by hand - Figure 2.

If no issue is evident and the Exhaust Flap oscillates freely by hand - replace the defective Exhaust Flap Control Unit, refer to *Repair Group. 26 Exhaust system – Exhaust flap control units (J883, 945) – To remove and fit.*
