# Technical Service Bulletin

**20 MIL on, DTC P310B00, P008700, P014800, P120F00 or P030000 stored in the ECM**

20 20 30 2060377/2 September 18, 2020. Supersedes Technical Service Bulletin Group 20 number 20-29 dated August 13, 2020 for reasons listed below.

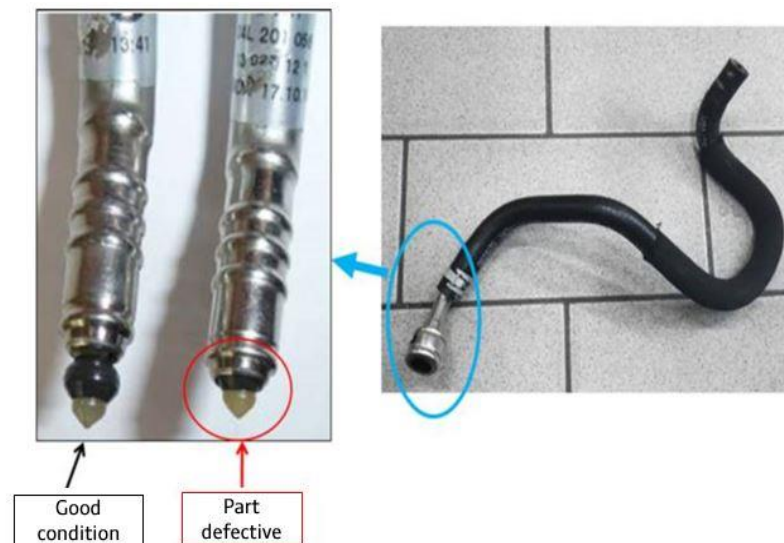
1. Check the fuel line 06M 133 986 AD (Quick Connector) for a defect. Compare with Figure 1.

**Figure 1.** Good condition part or defective part.

3. Should you find an irregularity, then replace the damaged component.
4. Please take photos and upload them into DOC-IT with the repair order. Photos should:
- Have a date stamp and VIN reference.
  - Be taken in focus and with sufficient light.
