# Technical Service Bulletin

**01 "Switch off the engine and check coolant" message in the instrument cluster, DTC P000000 is stored in the ECM**

01 20 91 2058890/3 October 7, 2020. Supersedes Technical Service Bulletin Group 01 number 20-73 dated July 24, 2020 for reasons listed below.

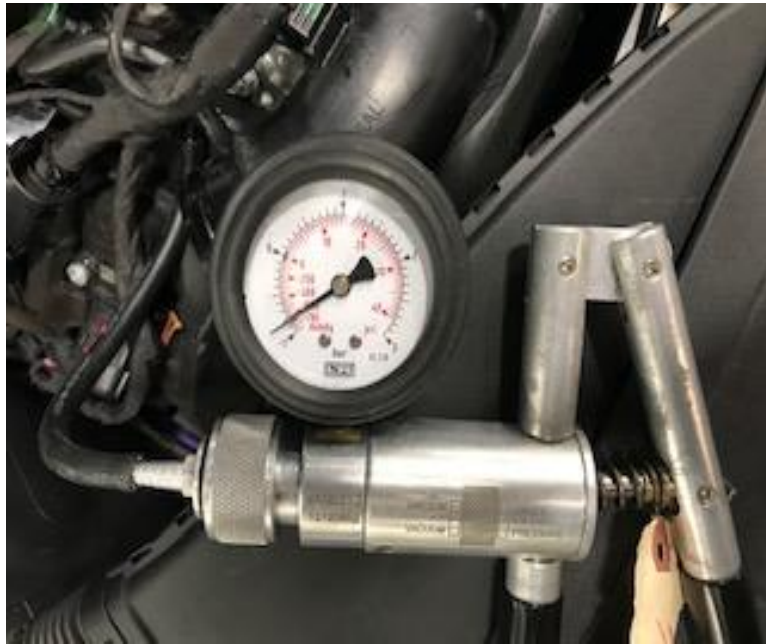
**A.** Check for vacuum (using VAS6213) at the output port of solenoid N649 which commands the water pump sleeve (Figures 1 and 2). The engine needs to be cold to generate a command signal to the N649 solenoid to switch to a vacuum. **With the engine cold,** start the engine briefly and monitor that vacuum is created.

**Figure 1.** Checking the vacuum at the output port of N649.

**B.** If there is no vacuum measured at the output port of N649, the cause of the fault could be related to the solenoid valve N649 or the vacuum hoses (check for leaks). In this case, repair and check the operation of the vacuum system.

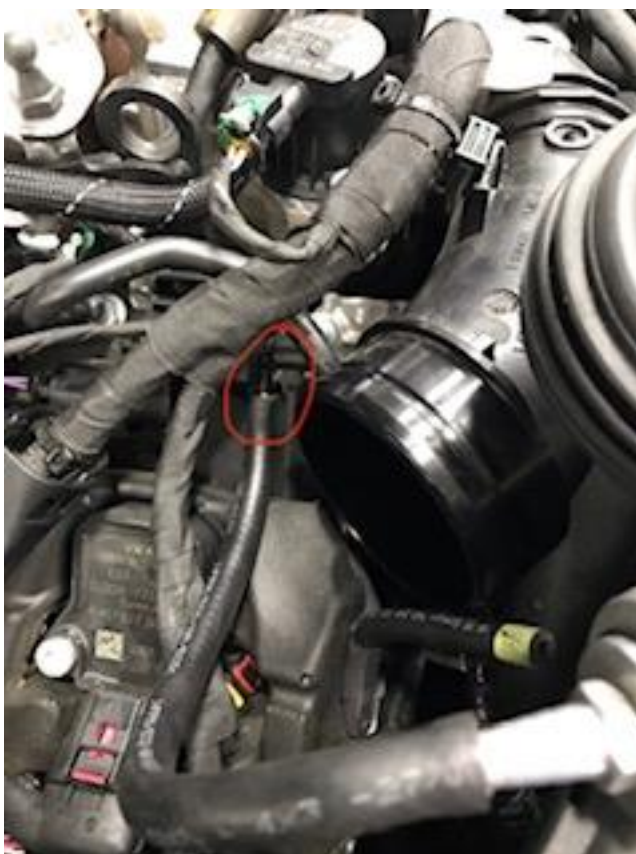
**Figure 2.** The output port of N649 (close-up picture).

4. If there are no malfunctions found in the vacuum system, check the operation of the water pump sleeve by applying a vacuum to the hose going to the water pump (hose connected to the output port of N649). When applying a vacuum to the pump, pay attention to the clicking sound of the water pump sleeve. If no clicking is heard or felt, replace the mechanical coolant pump.
