**NUMBER:** 18-086-20

**GROUP:** 18 - Vehicle Performance

Flash: Powertrain Control Module (PCM) Updates

This bulletin involves reprogramming the Engine Control Module (ECM) / Powertrain Control Module (PCM) with the latest available software.

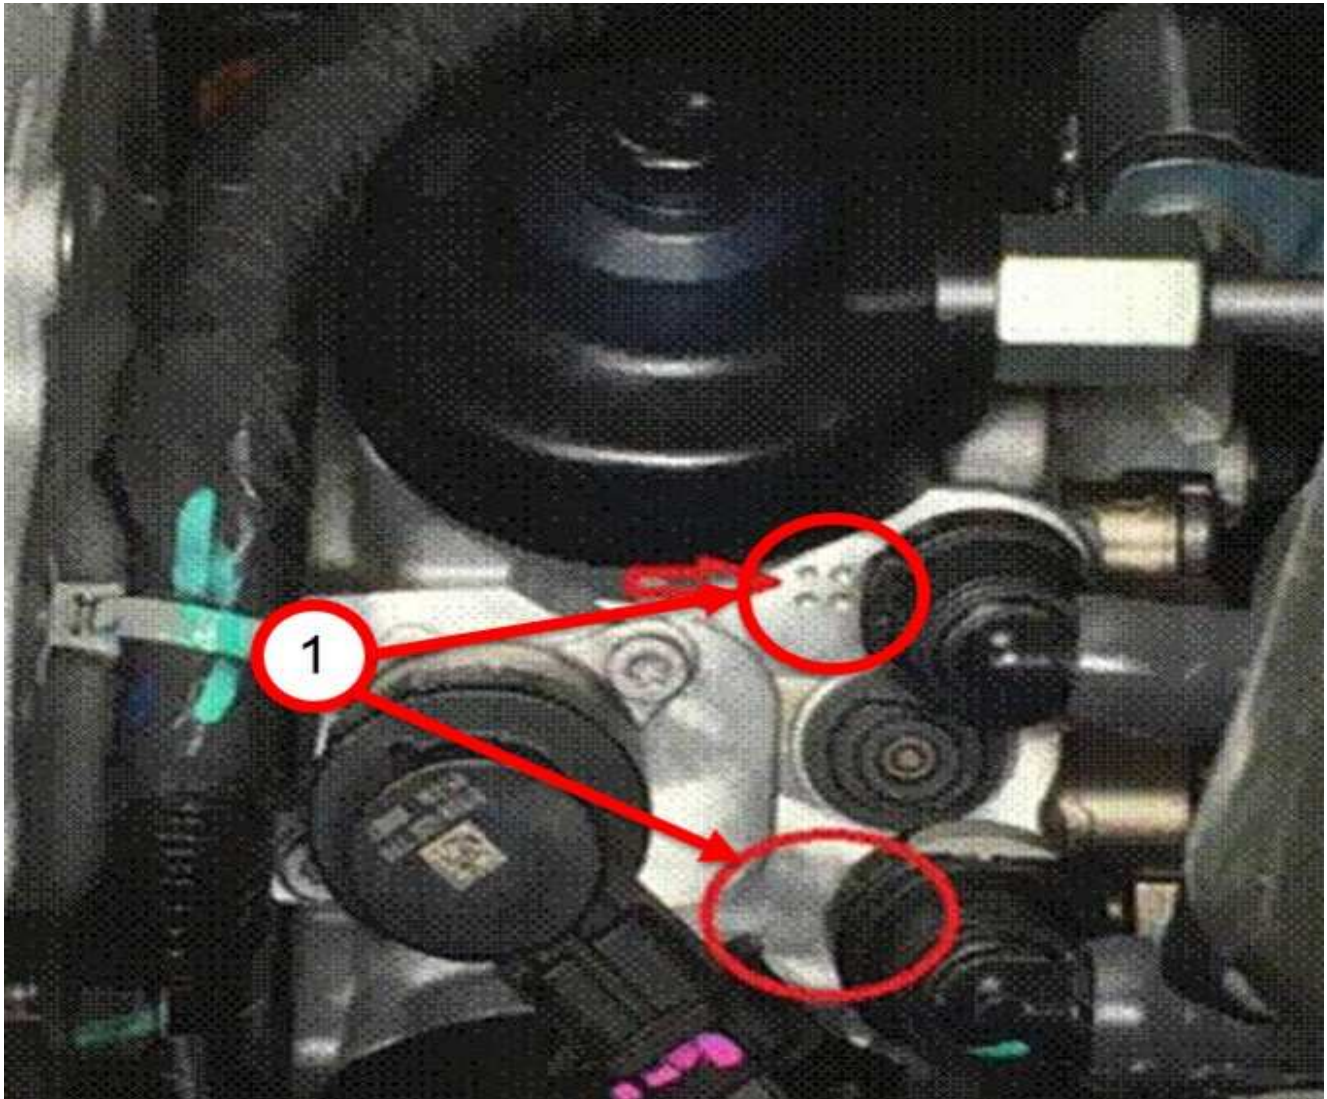
Fig. 2  
Old Style Asymmetrical Cam Design Pump

- Vehicles with the old style Asymmetrical Cam design will have multiple dots embossed in the pump housing (Fig. 2) .
- For vehicles with an Asymmetrical Cam pump, choose the calibration labeled Asymetric Cam or Asym Cam.

1 - Multiple Dots on Housing
