Subject: N192291620 - Special Coverage  
Camshaft Cover Replacement

Models: 2016 Buick Cascada

# Special Coverage Adjustment

## N192291620 Camshaft Cover Replacement

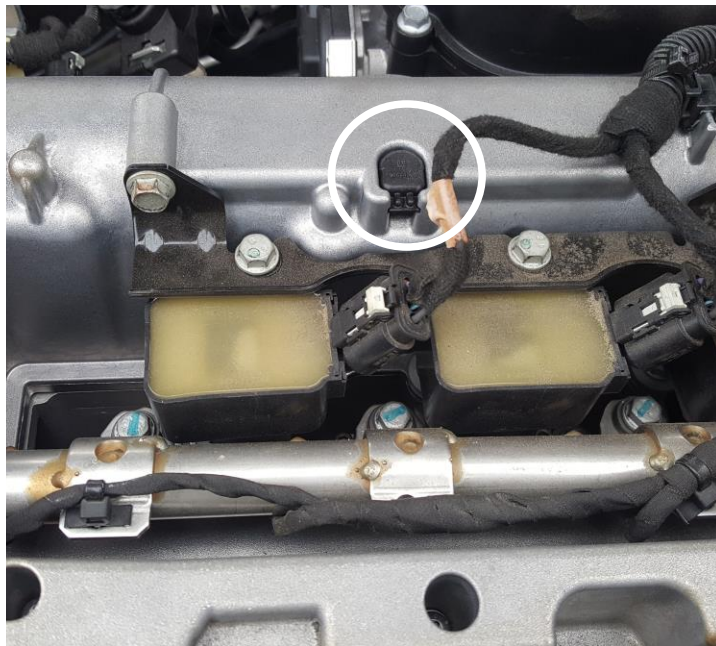
5509278

- 2.3 With the engine running, listen for noise coming from the PCV valve, shown above. If noise is heard, check to see if the noise gets quieter or disappears with the engine oil dipstick removed.
- 2.4 Reinsert the dipstick.
- 2.5 Check to see if there is vacuum at the PCV vent at the front of the PCV valve by placing a piece of tissue near it. The tissue will be sucked against the vent and held if vacuum is present.
  - If the PCV valve is making noise and there is vacuum present at the PCV valve vent, replace the Camshaft Cover. Refer to *Camshaft Cover Replacement* in SI.
