GLOBAL SAFETY FIELD INVESTIGATIONS  
DCS5509  
URGENT - DISTRIBUTE IMMEDIATELY

Subject: A202310450 - Service Update  
Engine Control Module Reprogramming for DTC P2B95 or P2B96 Set

Models: 2020 – 2021 Buick Encore GX  
2021 Chevrolet Trailblazer  
Equipped with 1.2L, 3-cylinder Gas Engine (RPO LIH)

### A202310450 Engine Control Module Reprogramming for DTC P2B95 or P2B96 Set

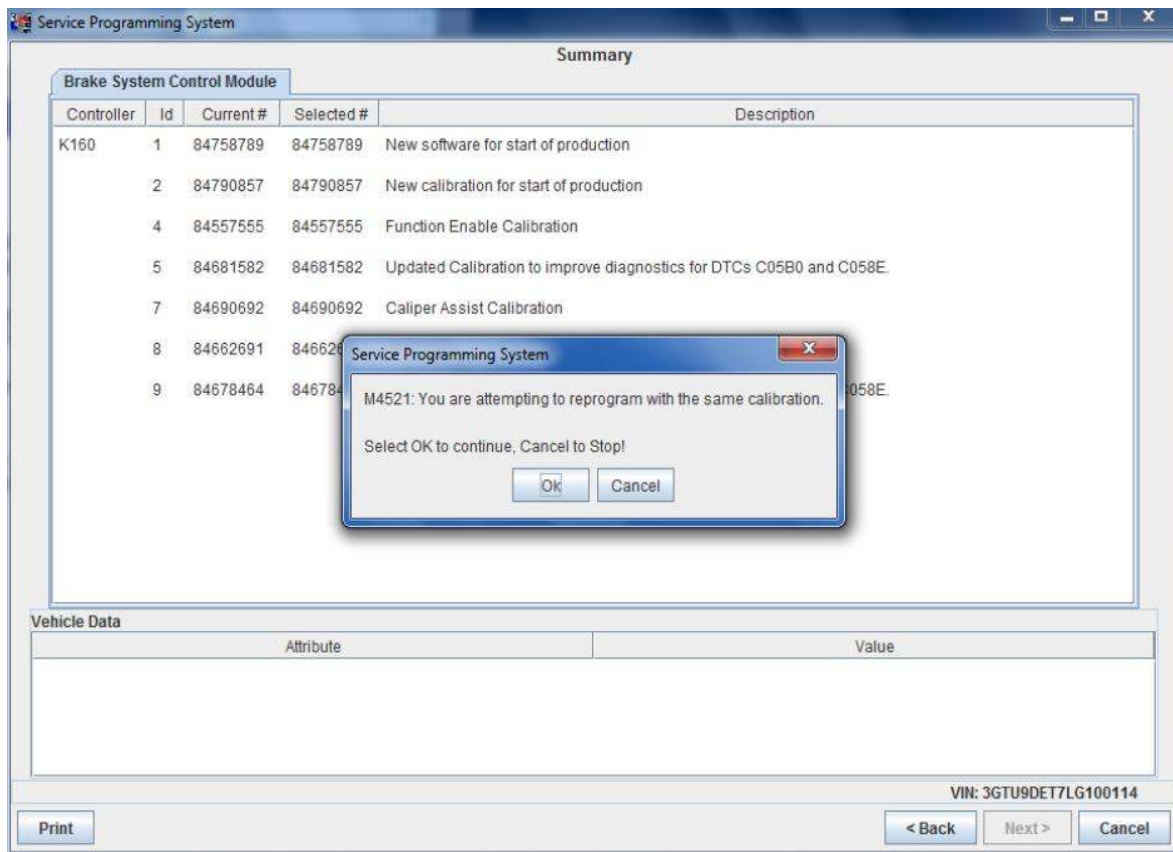
5431207

**Important:** Techline Connect and TIS2WEB screens shown above.

**Important:** If the same calibration/software warning is noted on the TLC or SPS Summary screen, select OK and follow screen instructions. After a successful programming event, the WCC is located in the Service Programming System dialogue box of the SPS Summary screen. No further action is required. Refer to the Warranty section of the bulletin.

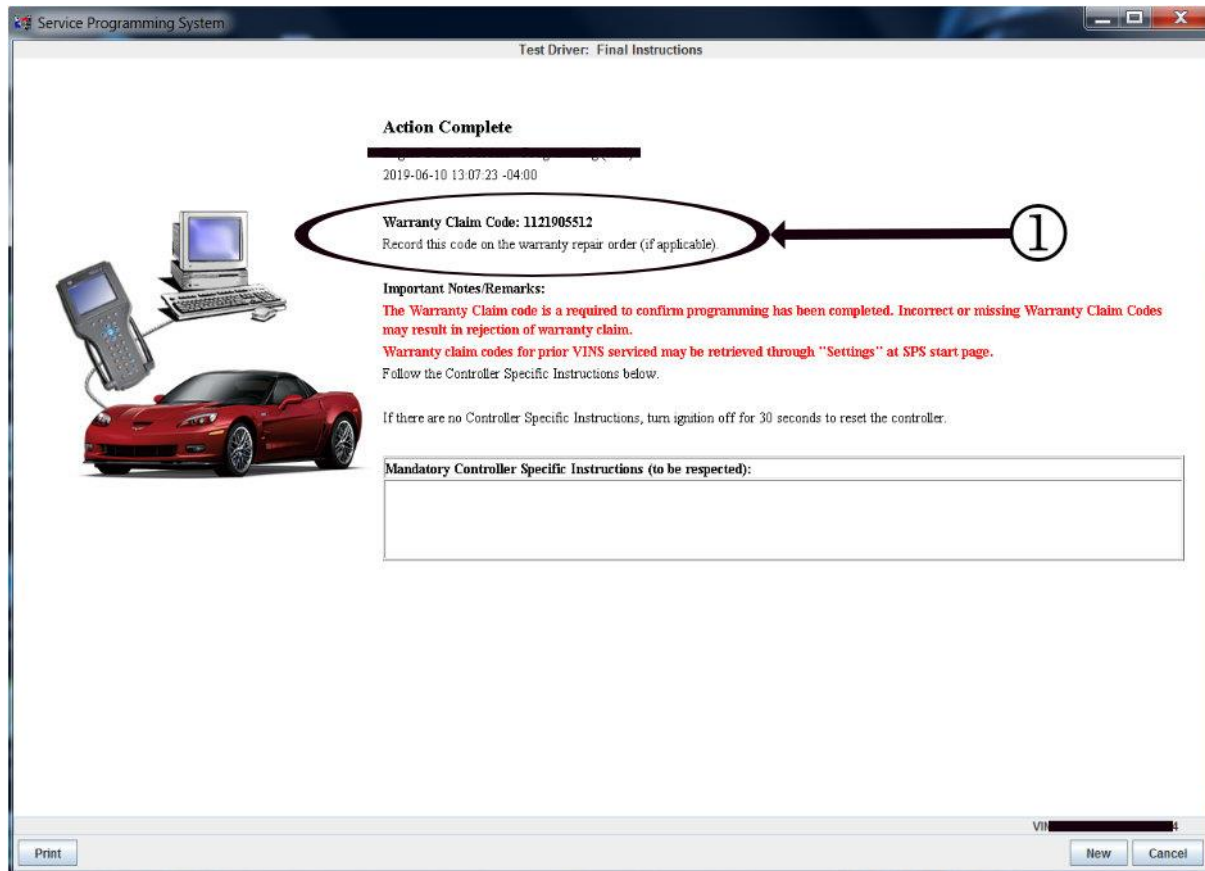
5431209

**Important:** To avoid warranty transaction rejections, you **MUST** record the warranty claim code provided on the Warranty Claim Code (WCC) screen shown above on the job card. Refer to callout 1 above for the location of the WCC on the screen.

2. Record SPS Warranty Claim Code on job card for warranty transaction submission.
