## Technical Service Bulletin

| GROUP<br><b>FUEL SYSTEM</b> | NUMBER<br><b>20-FL-010H</b> |
| DATE<br><b>OCTOBER 2020</b> | MODEL(S)<br><b>Tucson (TL) 2.0L</b> |

**SUBJECT:** TUCSON 2.0L DTC P0420 - ECM UPDATE AND CATALYST REPLACEMENT

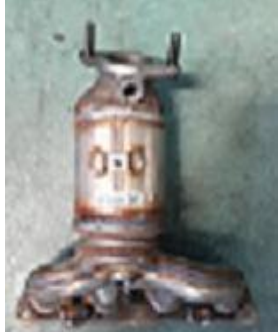
This bulletin provides information related to the repair of DTC P0420 "Catalytic Converter System Bank 1 - Efficiency Below Threshold" found stored in the Engine Control Module (ECM). The repair involves performing an ECM Update and replacement of the exhaust manifold catalyst.

1. Scan for DTC in Engine System and confirm that DTC P0420 is found stored.
2. Replace the exhaust manifold catalyst per the Shop Manual instructions.
