# Technical Service Bulletin

## 46 ABS warning light on, DTC C050200 and/or C050800 is stored in the ABS control module

46 20 19 2061331/1 November 18, 2020.

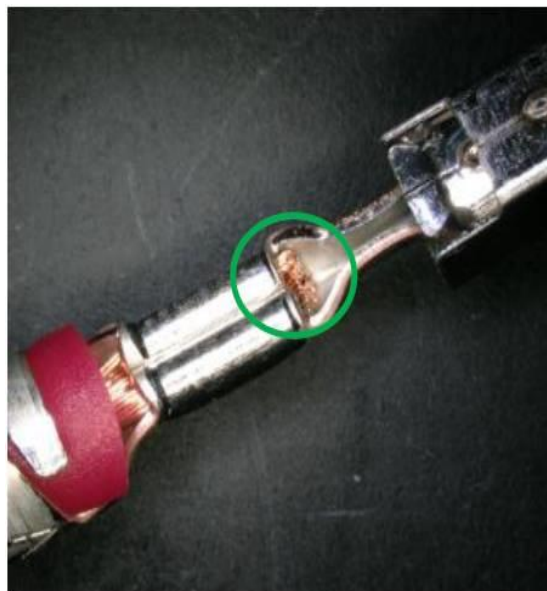
1. Ensure the strands of the wire are protruding past the crimp sleeve (Figure 1).

*Figure 1. Properly crimped wire.*

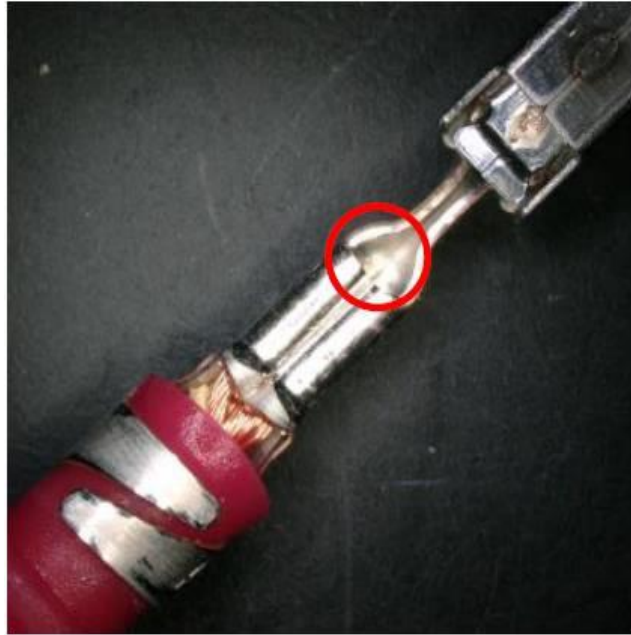
The ABS sensor wire may not be properly crimped to the pin of a front wheel speed sensor connector.

**Figure 2.** Improperly crimped wire.

2. If the wire is found to be improperly crimped, then replace the affected harness for the front speed sensor and brake pad wear indicator (Figure 2).

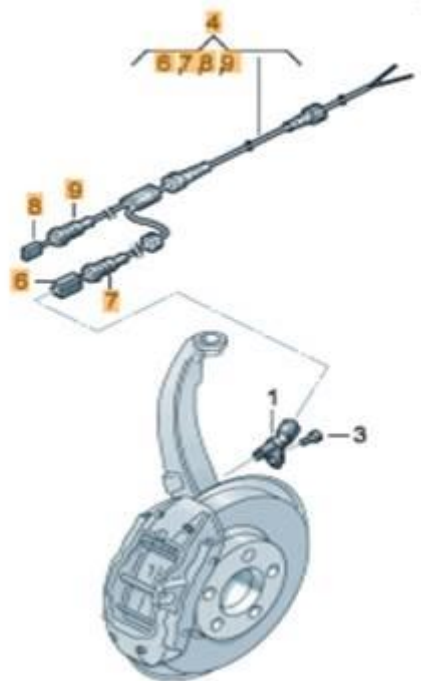
**Figure 3.** ETKA image of harness.

3. ETKA illustration 927-010 can be used to determine the harness needed (Figure 3).
