# Technical Service Bulletin

| <b>Subject:</b><br><br><b>WRONG VEHICLE LOCATION IN GPS WITH DTCS B119F:01,<br/>B119F:13 AND/OR B119F:2B STORED</b> | <b>Bulletin No.:</b> 09-021/20 |
| | <b>Last Issued:</b> 11/16/2020 |

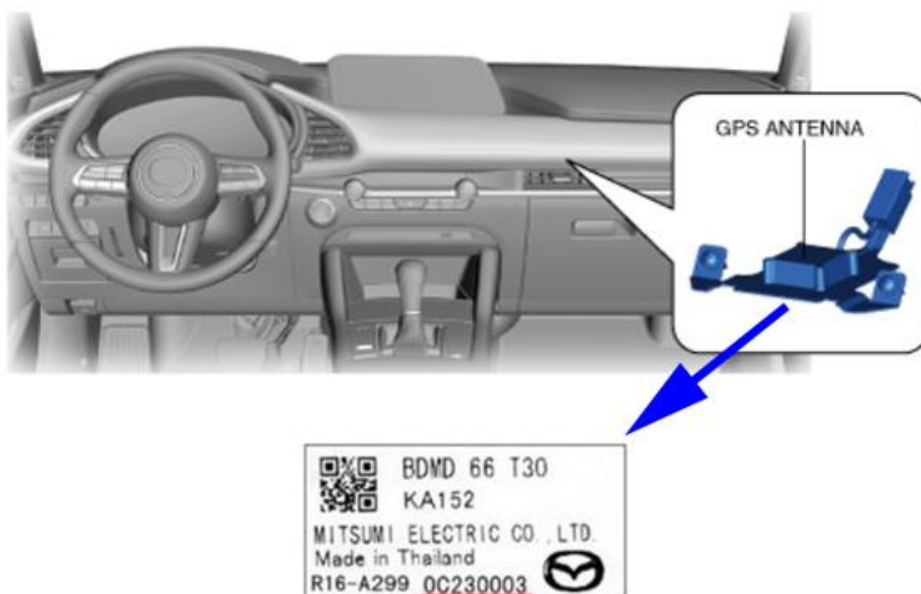
1. Verify customer concern.
2. Confirm if the telephone antenna No.1's lot number is before 0C230003. The lot number is in YMDDnnnn format.

Example:

0C230003: 0→2020 (year), C → March, 23→ 23th (day), 0003→serial number for the day

9H161360: 9→2019 (year), H → August, 16→ 16th (day), 1360→serial number for the day

- If the lot number is 0C230003 or later, the part is already modified.
- If the lot number is before 0C230003, replace the GPS antenna with a modified one by referring to the instructions on MGSS.
  - Mazda3: (GLOBAL POSITIONING SYSTEM (GPS) ANTENNA REMOVAL/INSTALLATION)
  - CX-30: (GLOBAL POSITIONING SYSTEM (GPS) ANTENNA REMOVAL/INSTALLATION)
