# Service Alert

| <b>Subject:</b><br><br><b>DTC U2050:55 STORED AFTER REPLACING OR REPROGRAMMING BCM</b> | <b>Service Alert No.:</b> SA-003/20 |
| | <b>Last Issued:</b> 11/06/2020 |

2019-2020 Mazda3  
2020 CX-30

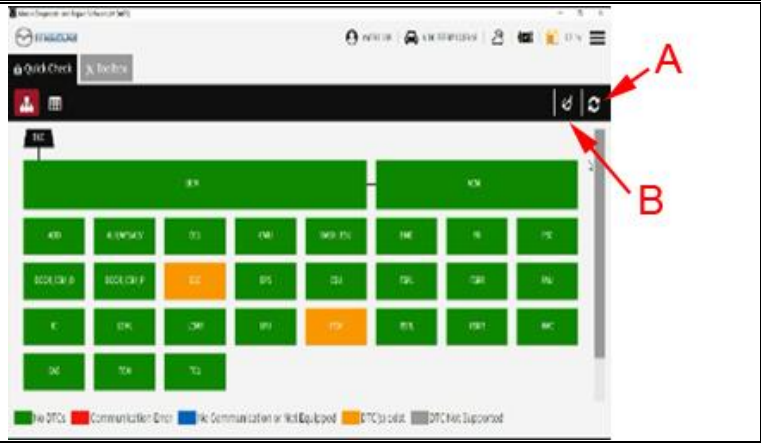
**CAUTION:** If the engine is not started, DTC P2610 is stored and cannot be erased.

6. Select Quick Check (A), then start the engine and select the DTC Clear icon (B).
