# Technical Service Bulletin

**DTC U2050:55 STORED AFTER REPLACING OR REPROGRAMMING  
TCU**

**Bulletin No.:** 09-013/20

**Last Issued:** 12/07/2020

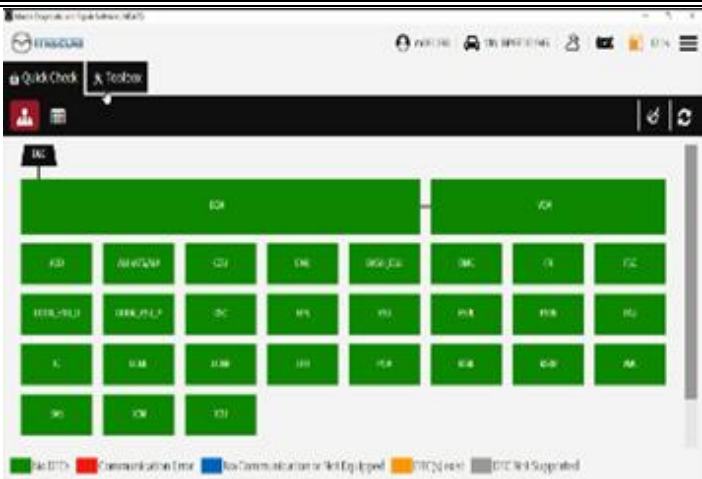
3a. Connect MDARS.

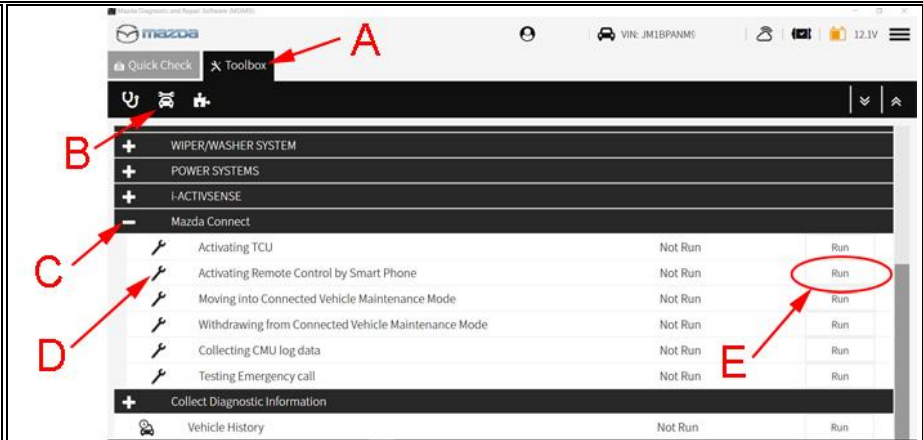
3b. Select the following:

- A. Toolbox
- B. Work support icon
- C. Mazda Connect
- D. Activating Remote Control by Smart Phone
- E. RUN.

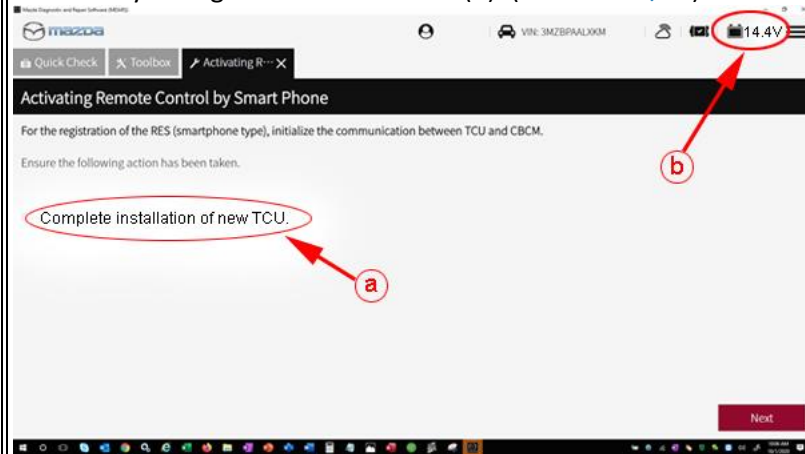
3c. Follow the on-screen instructions.

**NOTE:** Activating Remote Control by Smart Phone shows "Incomplete".

Possible causes:

- 1. The advanced key is not in the vehicle.
- 2. Connected Vehicle Maintenance Mode is enabled.
- 3. Key transmitter power saving function is enabled.
- 4. Pacemaker radio wave interference prevention function is enabled.

1. If TCU is not being replaced, ignore "Complete installation of new TCU" (a).
2. Battery voltage must be 14-14.5V (b). (see SA-063/20)

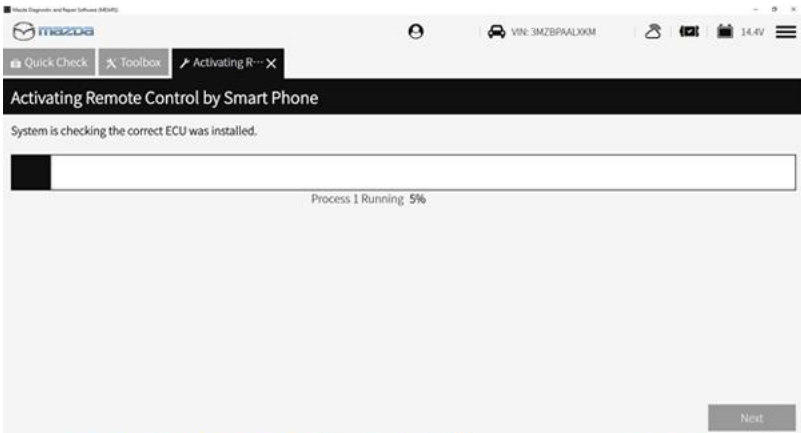
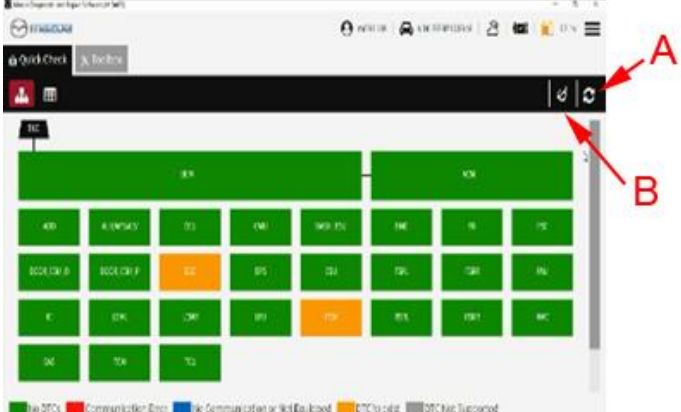
| <p>3d. Select Quick Check (A), then start the engine and select the DTC Clear icon (B).</p> <p><b>CAUTION:</b> If the engine is not started, DTC P2610 is stored and cannot be erased.</p> | |
