# Technical Service Bulletin

## 91 SOS warning displayed in instrument cluster, DTC B191604 is stored in the gateway control module

91 20 58 2051664/3 December 18, 2020. Supersedes Technical Service Bulletin Group 91 number 19-33 dated February 5, 2019 for reasons listed below.

| Model(s) | Year | VIN Range | Vehicle-Specific Equipment |
|---|---|---|---|
| A4, A5, Q5, and Q7 | 2018 | All | connected gateway |

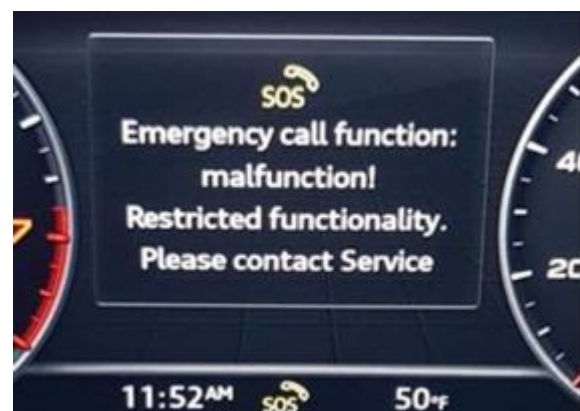
- The warning message "Emergency call function: malfunction! Restricted functionality. Please contact Service" appears in the instrument cluster (Figure 1).

**Figure 1.** The warning message is shown in the instrument cluster.

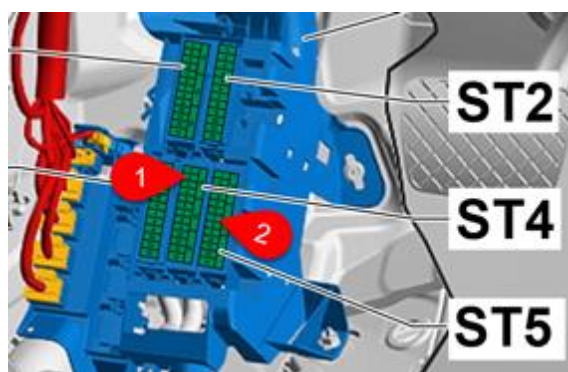
**Figure 2.** Q7 Driver's Side Footwell Fuse Box. 1: KL15 Fuse. 2: KL30 Fuse.

1. Perform a manual discharge of the connected gateway's back-up battery by removing constant power (KL30) and accessory power (KL15), while KL15 is switched on.

2. Gain access to fuse panel SB, located behind the driver's side footwell cover. Consult the repair manual for instructions on accessing fuse panel SB.
3. Locate the two fuses which supply constant power (KL30) and accessory power (KL15) to the connected gateway. Consult the wiring diagram or owner's manual for fuse location and size.
4. Ensure that accessory power (KL15) is ON.
5. Remove the two fuses identified in Step 3.
6. Wait 30 seconds with both fuses removed.
7. Reinstall the two fuses.

8. Turn off accessory power (KL15).
  9. Repeat steps 4 through 8 **seven** additional times. This will result in a total of seven discharge cycles.
  10. Following seven discharge cycles, clear the fault memory of the connected gateway module:
    - In ODIS GFF, recheck the fault memory of the connected gateway.
    - The fault should now be static and should not return after clearing the fault memory.
- If the fault does not clear and is marked as Active, then replace the connected gateway's backup battery. Consult the repair manual for instructions on replacing the connected gateway's backup battery. Consult the parts catalog for the correct part number of the connected gateway's backup battery.
