# SERVICE BULLETIN

EC20-020

NTB20-094

## 2015-2020 ROGUE; MIL ON WITH DTC P0181 AND/OR P0183

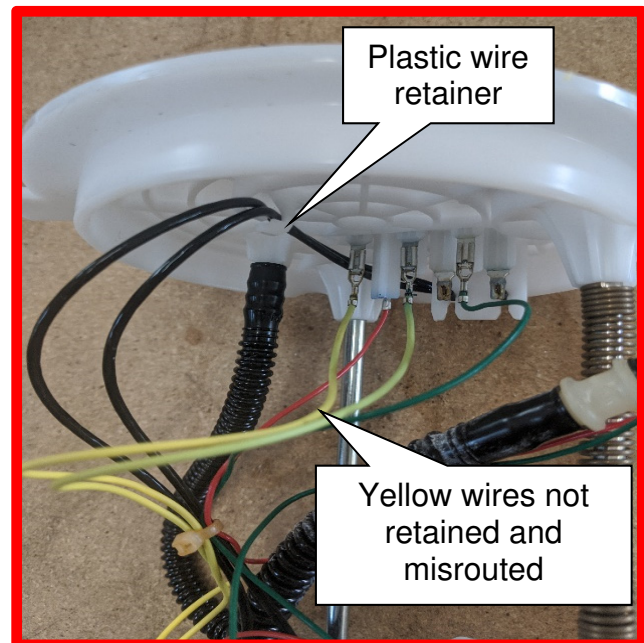
Figure 2

The MIL is ON with DTC P0181 (FTT SENSOR) and/or P0183 (FTT SEN/CIRCUIT) stored in the ECM.

2. Inspect the routing of the yellow wires on the fuel pump assembly. The yellow and black wires should be routed the same way and retained at the top by the plastic wire retainer as shown in Figure 1.
  - If the wires are routed correctly, continue to step 3.
  - If the wires are not routed correctly, as shown in Figure 2, route them as shown in Figure 1.
