# Random Misfire Under High Load

**Service****Category** Engine/Hybrid System**Section**

| YEAR(S) | MODEL(S) | ADDITIONAL INFORMATION |
|---|---|---|
| 2019 | Avalon | WMI(s): 4T1<br>VDS(s): BZ1FB |
| 2018 | Camry | WMI(s): 4T1<br>VDS(s): BZ1HK |

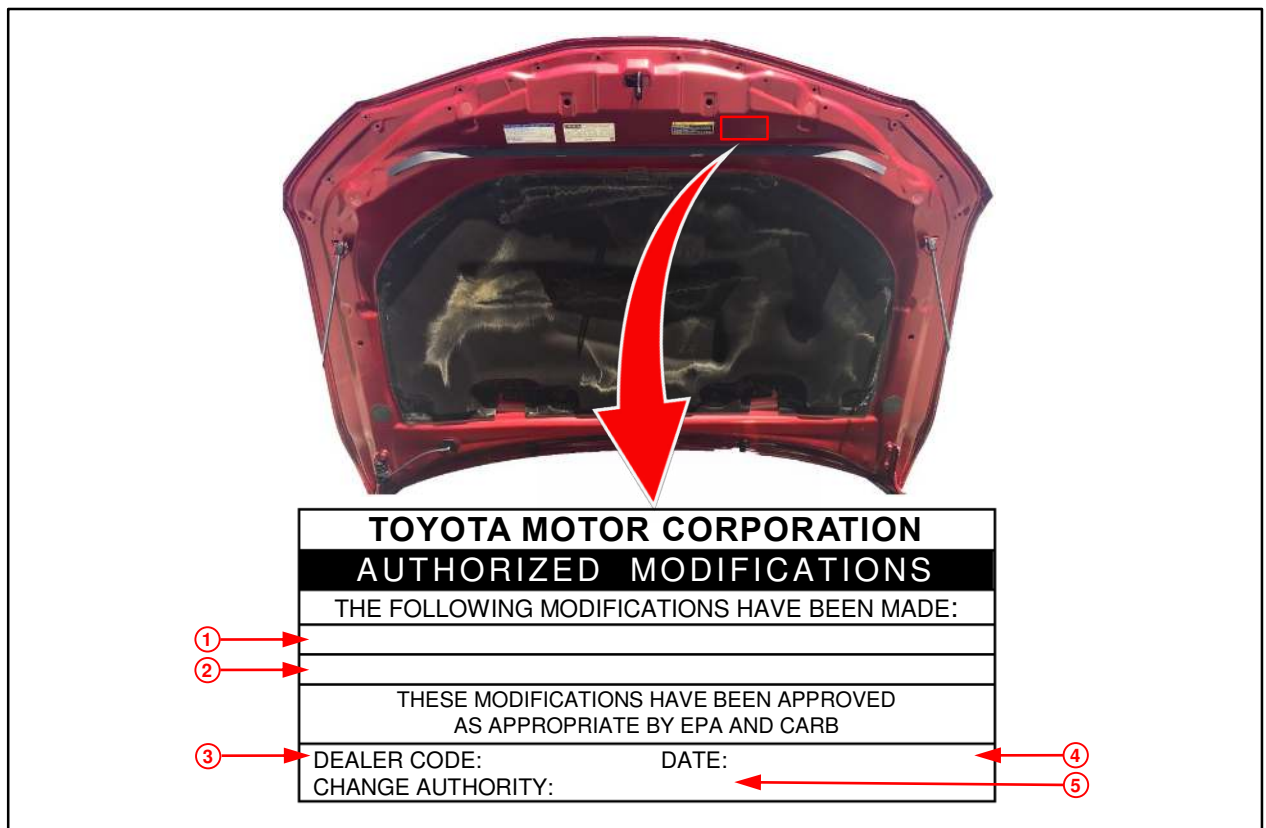
**Figure 1. Location of Authorized Modifications Label on 2019 Avalon**

4. Use Techstream to confirm if the ECM (PCM) calibration has been updated and check for the Authorized Modifications Label affixed to the vehicle in the location shown below.

6. Prepare and install the Authorized Modifications Label.
  - A. Using a permanent marker, enter the following information on the label:
    - ECM (PCM) part number [*Refer to the **Parts Information** section for the **NEW PART NUMBER**.*]
    - Calibration ID(s) [*Refer to the **Calibration Information** section for the **NEW CALIBRATION ID**.*]
    - Dealer Code.
    - Repair Date.
    - Change Authority [***This bulletin number***].
  - B. Install the Authorized Modifications Label onto the vehicle at the location shown in Figure 1. The Authorized Modifications Label is available through the MDC, P/N 00451-00001-LBL.
7. Test-drive the vehicle to confirm proper operation.
