# Technical Service Bulletin

**20 MIL on, DTC P310B00, P008700, P014800, P120F00 or P030000 are stored in the ECM**

20 21 34 2060377/3 January 25, 2021. Supersedes Technical Service Bulletin Group 20 number 20-30 dated September 18, 2020 for reasons listed below.

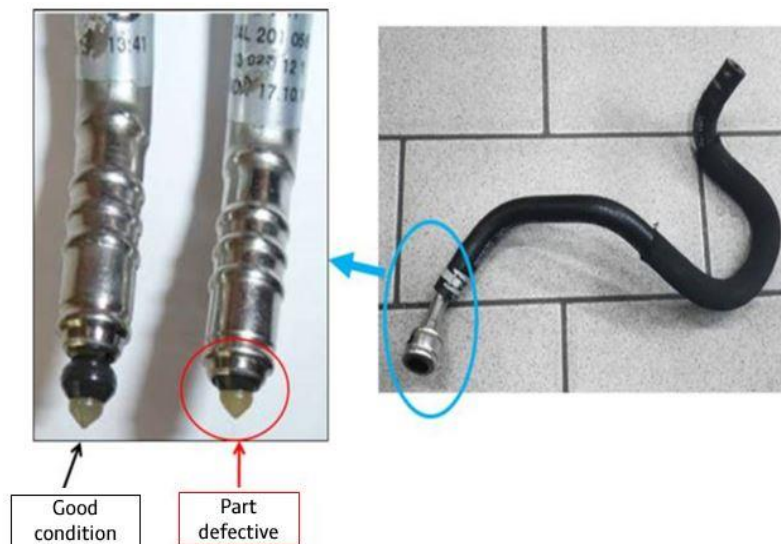
1. Check the fuel line 06M 133 986 AD (Quick Connector) for a defect (Figure 1).

**Figure 1.** Good condition part or defective part.

3. Should you find an irregularity, then replace the damaged component.
4. Please take photos and upload them into DOC-IT with the repair order. Photos should:
- Have a date stamp and VIN reference.
  - Be taken in focus and with sufficient light.

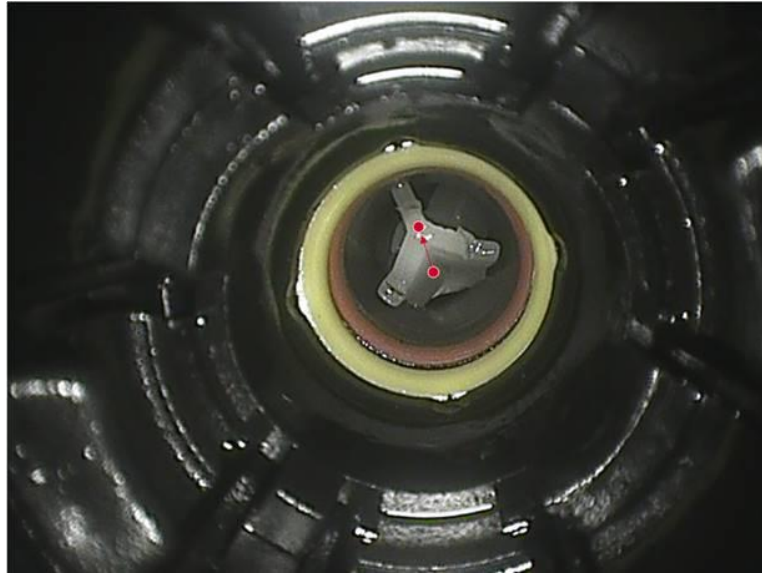
2. A non-concentric fit of valve stem can be a further indication of internal component damage (Figure 2).

**Figure 2.** Check the valve stem fit.
