# Technical Service Bulletin

## 90 Drive select menu is greyed out in the MMI, DTC U111000 is stored in the information electronics control module

90 21 86 2061989/1 January 28, 2021.

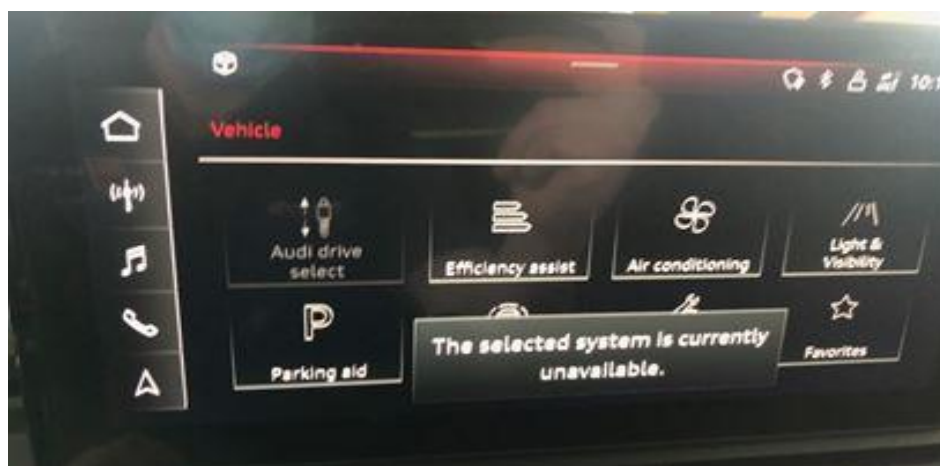
- The drive select menu is greyed out in the MMI and the message “The selected system is currently unavailable” appears (Figure 1).

**Figure 1.** Drive select is unavailable.

The following DTC is stored as static in the information electronics 1, J794 (address word 005F)

- DTC U111000** (Function restriction due to communication interruption) with symptom code 7191.

If the above condition and DTC are present, perform the replacement test plan for the Gateway, J533 (address word 0019) as follows:

1. At the first prompt, use selection 2 – New control module (Figure 2).

2. At the second prompt, use selection 1 – No SVM code (Figure 3).  
- Check whether your ordering system/parts catalog (e.g. ETKA, special note, ...) or one of the available Technical Service Bulletins (TSB) indicates a SVM code (e.g. XCHG...).

3. Follow the on screen prompts.
4. Once complete allow a 10 minute sleep cycle and re-check the operation. Drive select functions are now restored and the DTC can be cleared.
