# Technical Service Bulletin

CHECK ENGINE LIGHT ON WITH DTC P2610 AND P2507

**Bulletin No.:** 01-003/21

**Last Issued:** 01/26/2021

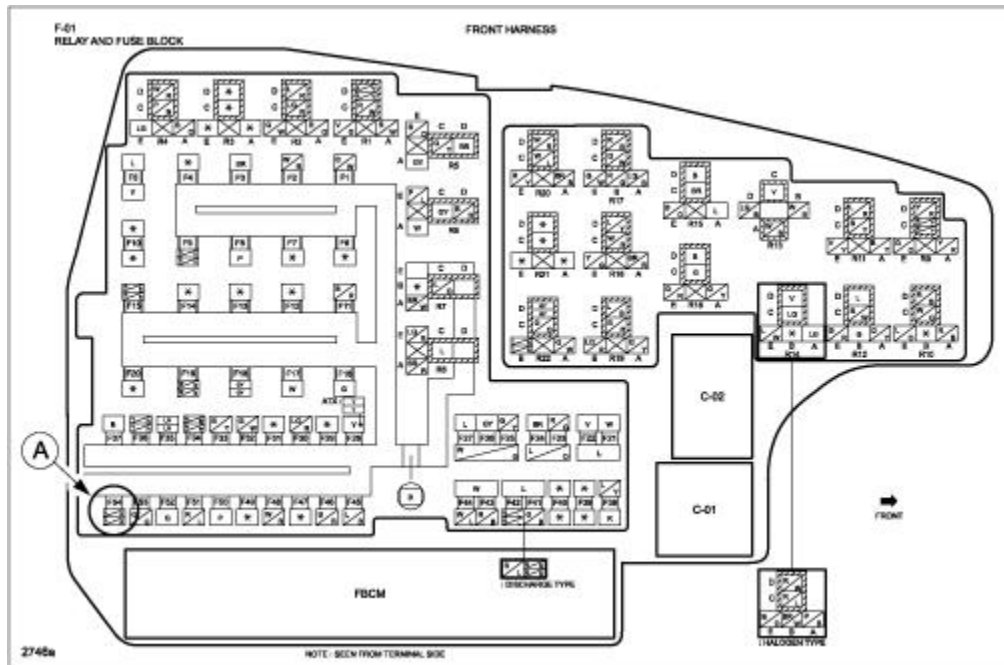
Some vehicles may experience the CHECK ENGINE LIGHT ON with DTC P2610 and P2507 stored in memory after engine start and room fuse 15A (A) removed.

- P2610:00: Instrument cluster internal engine off timer performance problem
- P2507:00: PCM battery voltage low input

As a past malfunction, the customer will not notice it (no warning light illuminated), but the DTC may be found during a vehicle service. P2507 in this situation is only applicable on 2016 and later models.

This is caused by the engine being started 3 or more times after a short duration of engine off (less than 15 seconds) with the room fuse removed.

1. Verify DTC P2610 and P2507 are stored in PCM memory.
2. Install ROOM fuse 15A with ignition OFF.
3. Start the engine and let it run for at least 10 seconds, then stop the engine.
4. Start the engine again and verify that the CHECK ENGINE LIGHT is not illuminated, then stop the engine.
5. Clear DTC P2610 and P2507 from PCM memory using IDS.
6. Verify no other DTCs are stored in memory. If so, troubleshoot them according to the MGSS online instructions or Workshop Manual.

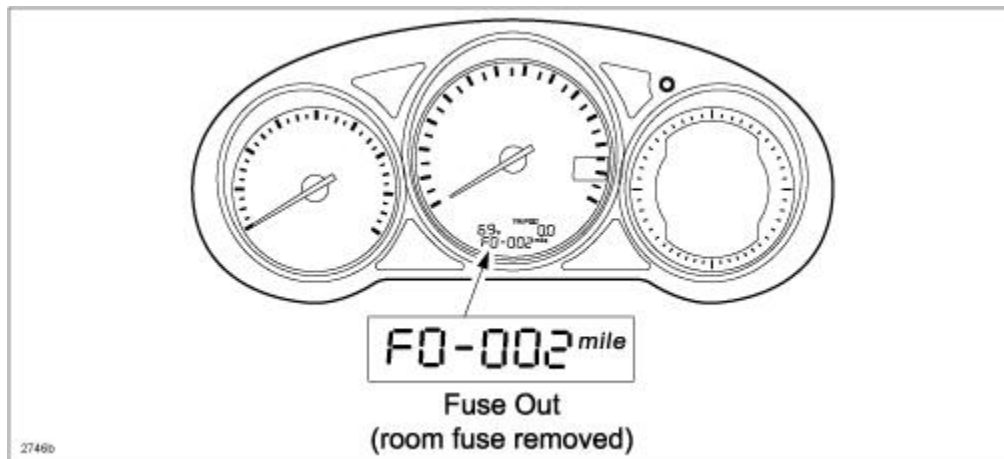
**NOTE:** The odometer will display "F0-002" during transport mode (room fuse 15A removed). Transport mode is canceled when room fuse 15A is installed or the vehicle odometer is more than 12.4mi (20km).

Vehicles in dealer inventory with this concern should be repaired using the following repair procedure.
