ITB20-025a

## DTC B2724-23 AND/OR C1B56-04 STORED, AND/OR RAB ERROR MESSAGE OR WARNING

**APPLIED VEHICLES:** 2020-2021 QX50 (J55)

**APPLIED SYSTEM:** Rear Automatic Braking

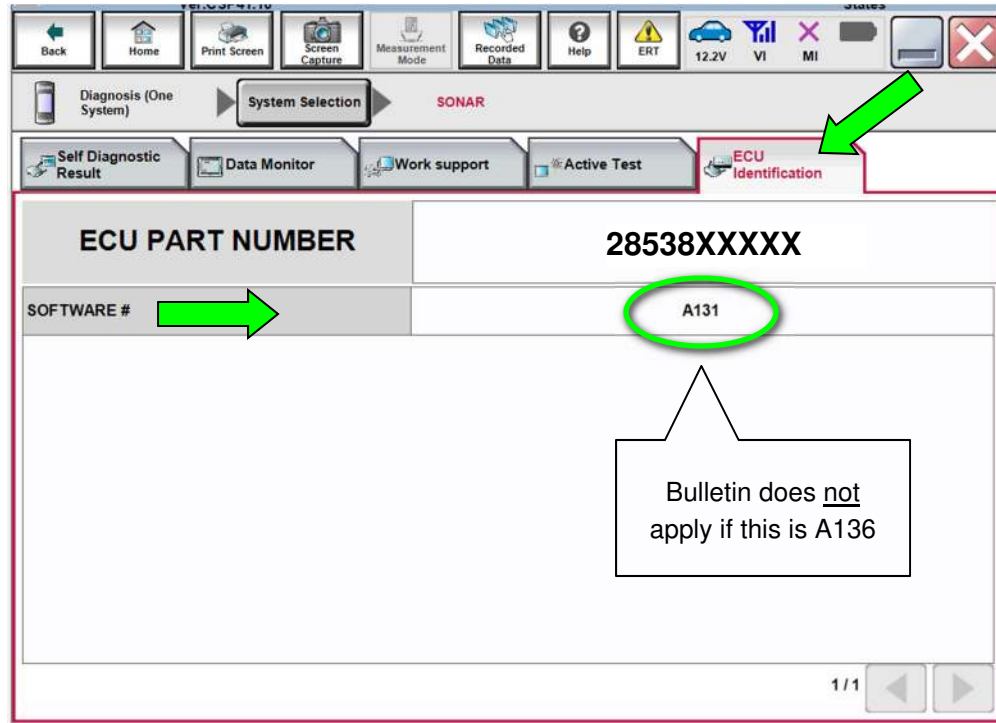
Figure 5

12. Select ECU Identification.
13. Confirm the SOFTWARE #. See Figure 5.
  - If the SOFTWARE # is A136, this bulletin does not apply. See the Electronic Service Manual (ESM) for further diagnostic information.
  - If the SOFTWARE # is not A136, proceed to step 14.

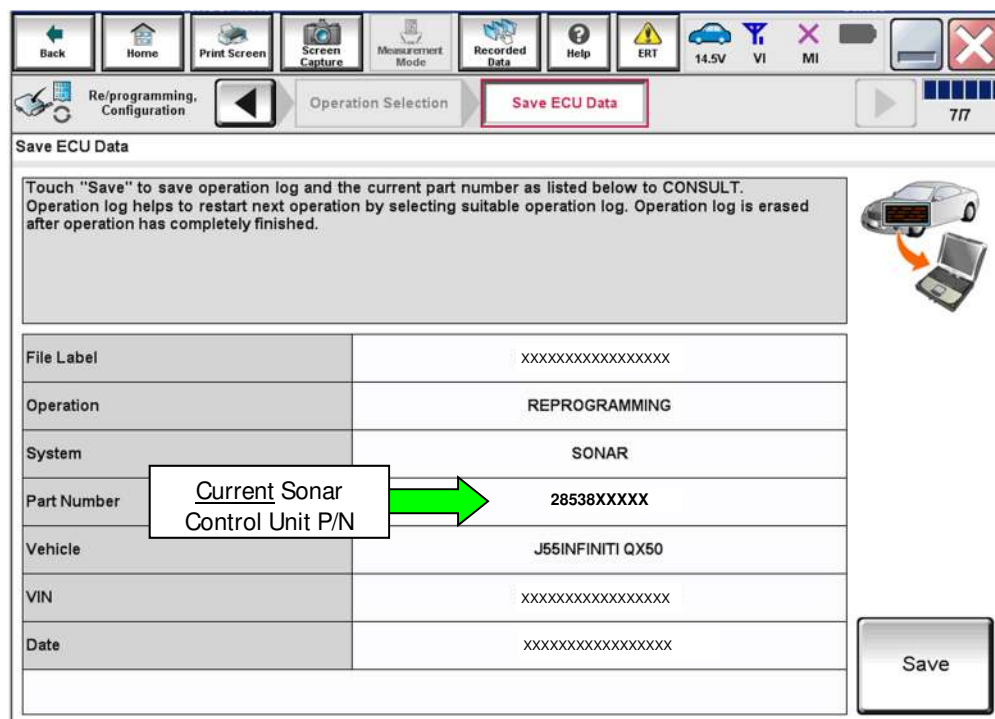
Figure 14

25. When you get to the screen shown in Figure 14, confirm that a reprogram is available as follows.

- A. Find the Sonar Control Unit Part Number and write it on the repair order.

B. Compare the part number you wrote down to the part numbers in Table A.

- If there is a match, continue with the reprogramming procedure.
- If there is not a match in Table A, this bulletin does not apply. See the ESM for further diagnostic information.

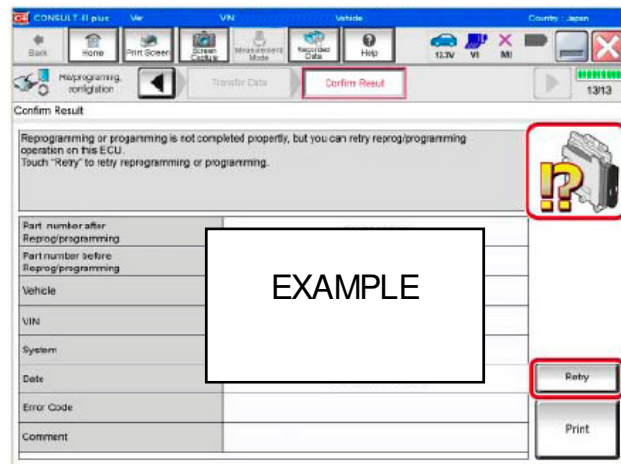
Figure 25

If reprogramming does not complete and the “!?” icon displays as shown in Figure 25:

- Check battery voltage (12.0 - 15.5 V).
- Ignition is ON, engine OFF.
- External Bluetooth® devices are OFF.
- All electrical loads are OFF.
- Select retry and follow the on screen instructions.
- “Retry” may not go through on first attempt and can be selected more than once.

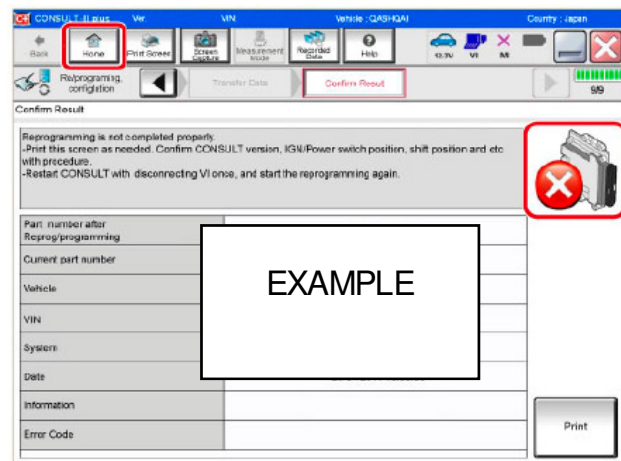
Figure 26

If reprogramming does not complete and the “X” icon displays as shown in Figure 26:

- Check battery voltage (12.0 - 15.5 V).
- CONSULT A/C adapter is plugged in.
- Ignition is ON, engine OFF.
- Transmission is in Park.
- All C-III plus / VI cables are securely connected.
- All C-III plus updates are installed.
- Select Home, and restart the reprogram procedure from the beginning.

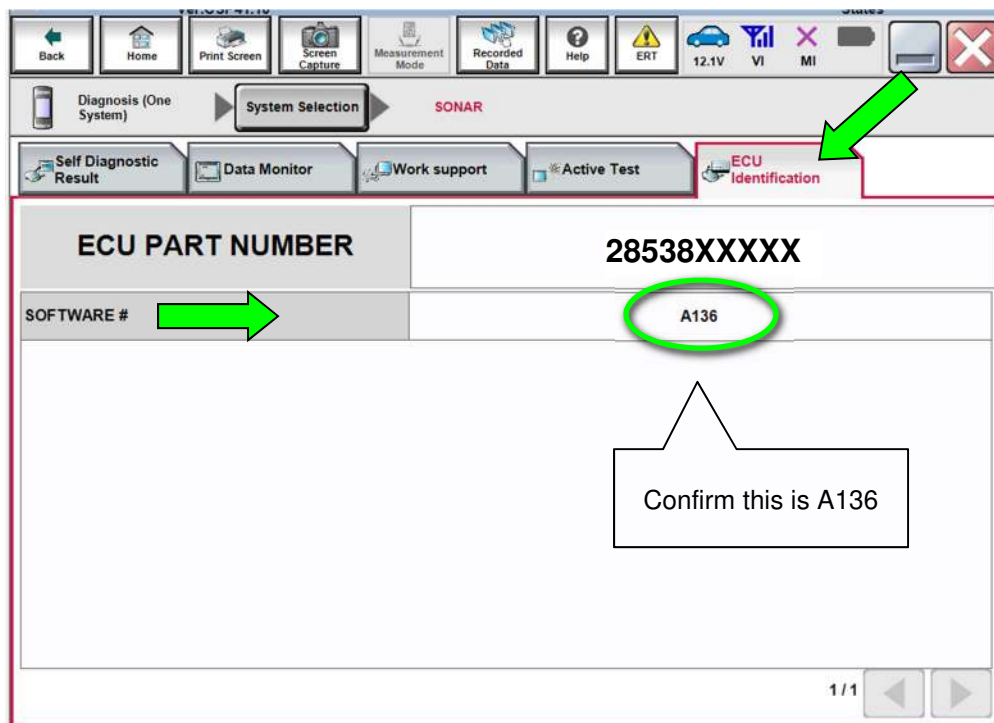
Figure 39

62. Confirm the SOFTWARE #. See Figure 39.

- If the SOFTWARE # is A136, proceed to step 63.
- If the SOFTWARE # is not A136, reprogramming did not successfully complete. Go back to step 15 on page 6 and perform the procedure again.

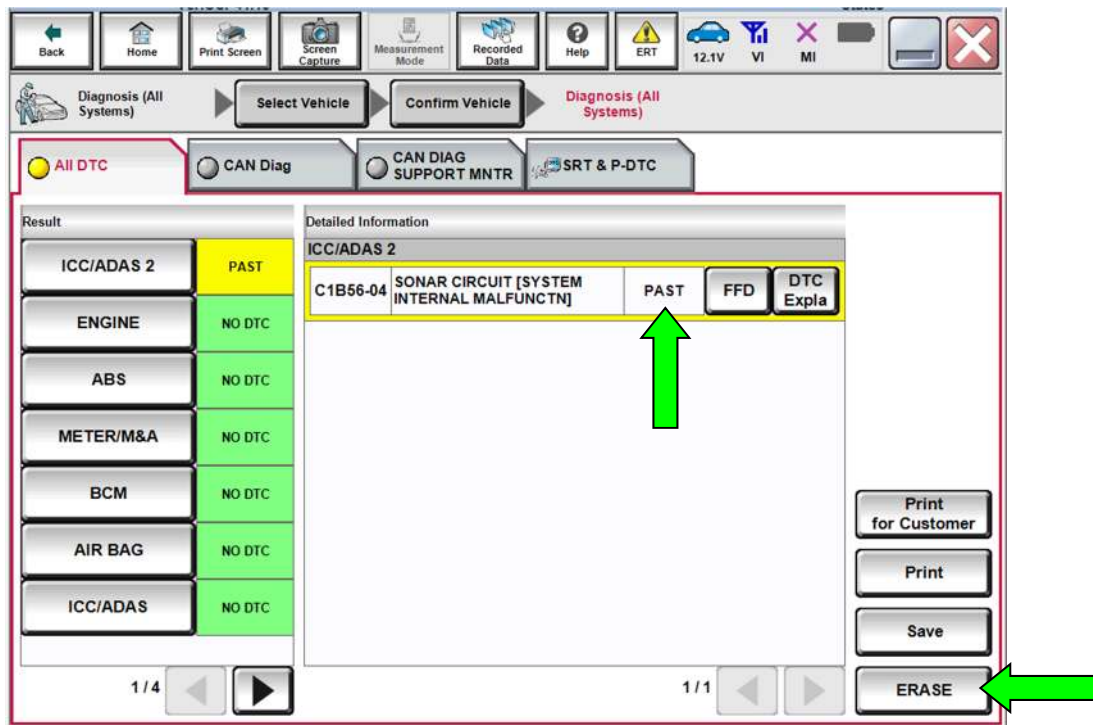
Figure 42

65. Select Automatic Selection(VIN).
66. Select Confirm.
67. Select Confirm.
68. Turn the ignition OFF, then turn the ignition ON.
69. Confirm DTC C1B56-04 is displayed as PAST (not CRNT). See Figure 42.
70. Select ERASE.
