NUMBER  
**231 (Rev 1, 04/28/2021)**

## TECHNICAL SERVICE BULLETIN

**FRONT VIEW CAMERA REPLACEMENT  
FOR DTC C160449 & C160649**

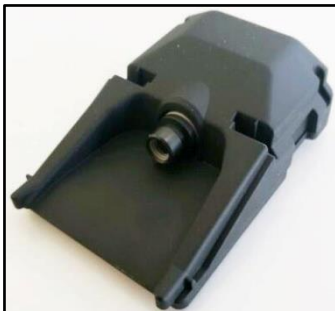
This bulletin provides information on the inspection and replacement of the front camera on some vehicles listed below. Due to an internal control chip concern inside the camera, the vehicle may exhibit an MIL on with DTC C160449 and/or C160649. Certain systems may become temporarily disabled during occurrences: Smart Cruise Control (SCC), Lane Keep Assistance (LKA), Lane Departure Warning (LDW), Forward Collision-Avoidance Assist (FCA), Forward Collision Warning (FCW) and/or Driver Attention Warning (DAW). Follow the procedure outlined in this publication to diagnose and replace the front view camera assembly.

Front View Camera  
(image is representative only)
