# Service Bulletin

Bulletin No.: 21-NA-032

**Subject:** DTC P0101 Mass Air Flow (MAF) Sensor Performance, P1682 Set after MAF Replacement

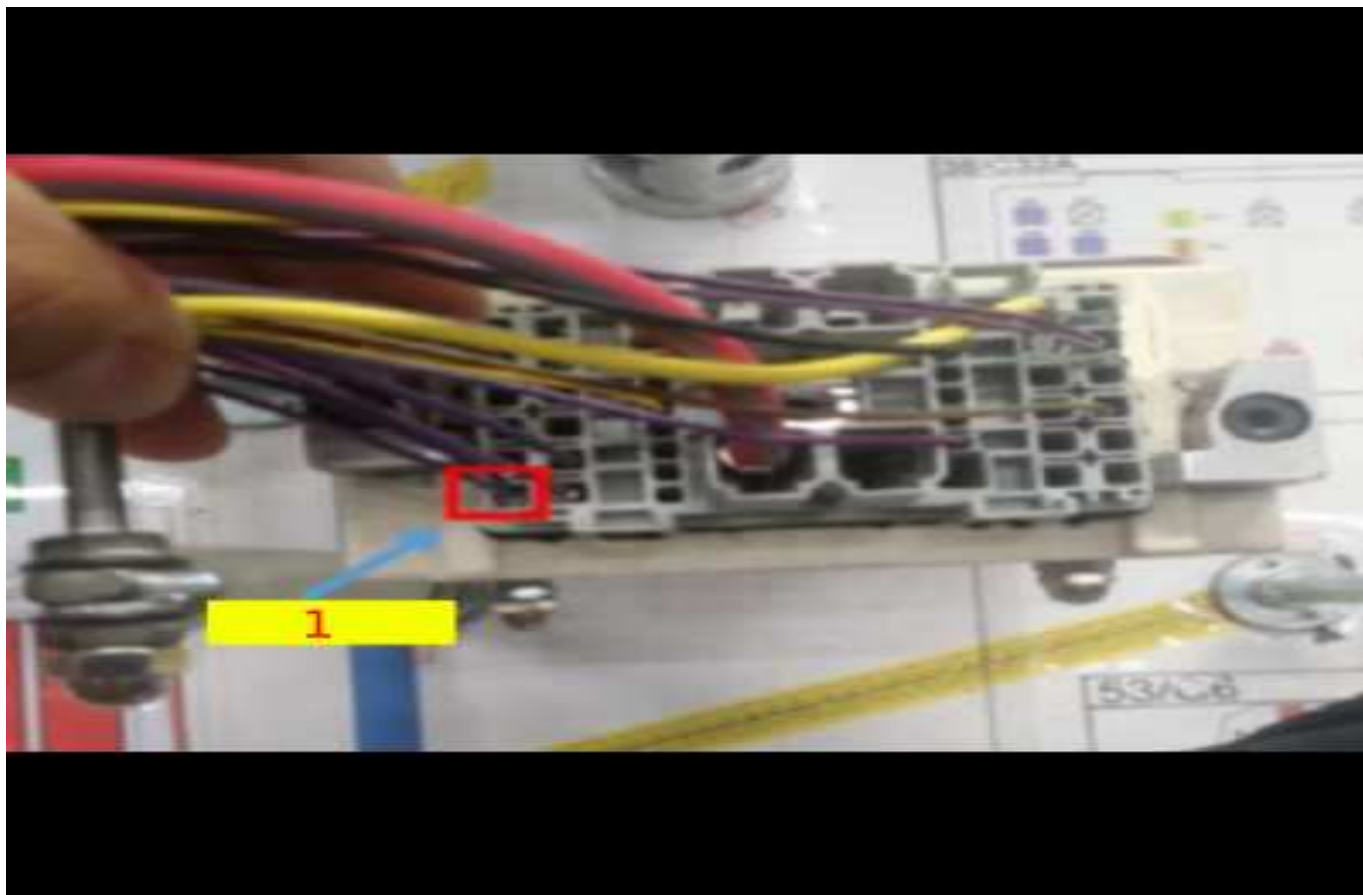
5735855

1. Locate the X50A Fuse Block- Underhood X3 Connector

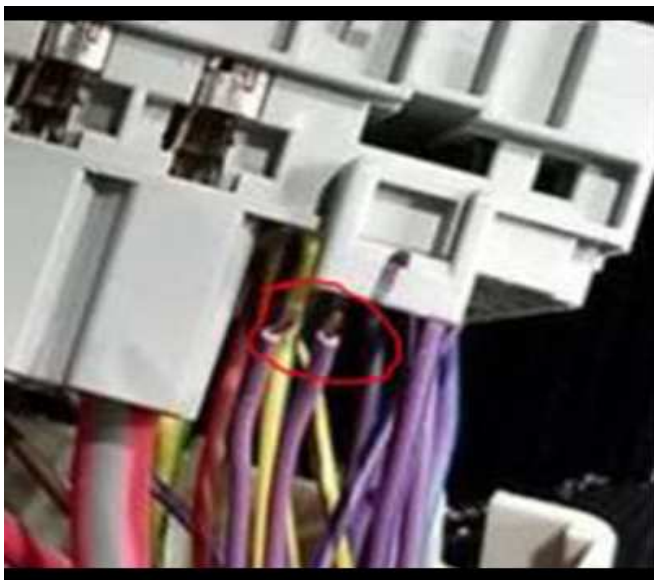
5735789

2. Locate the dual-crimp wire in the H6 pin (1).
3. Verify the dual crimp wire at the H6 pin

" If the dual crimp is like the example above, repair the wire. Refer to Repairing Connector Terminals (Terminal Repair) in SI.
