# Technical product information

| <b>Topic</b> | New Continental GT, GTC, New Flying Spur - Blind spot monitors not functional DTC C1114F3 logged in address 003C or 00CF |
| <b>Transaction No.</b> | 2062884/1 |

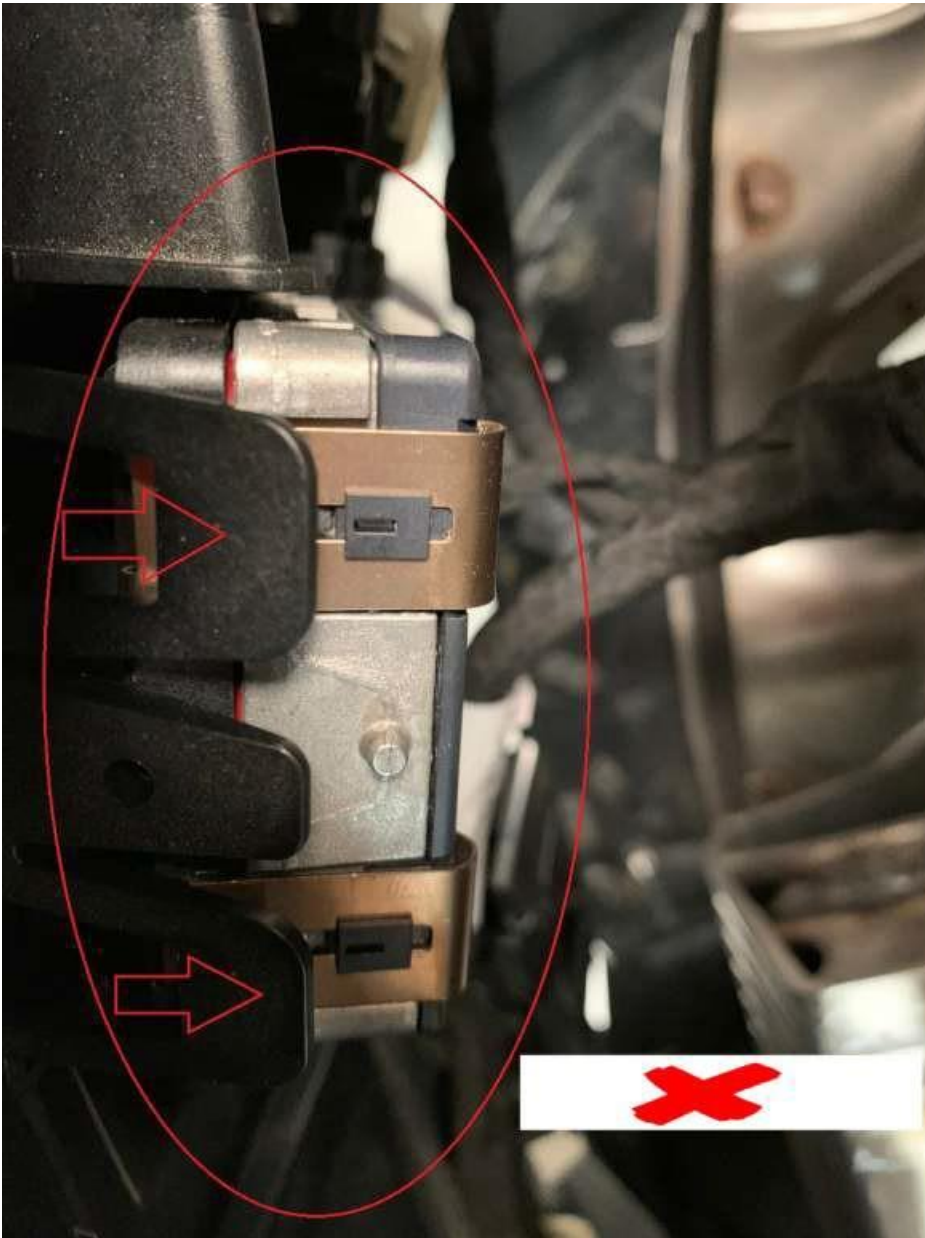
Figure 2

Master or slave rear radars are not fitted correctly (unclipped or poorly installed)

- 003C: Inspect the RHS rear radar fitment and/or bracket damage
- 00CF: Inspect the LHS rear radar fitment and/or bracket damage

3) In the event one or both control units are loose/detached - Refer to Figures 2 (Before adjustment) and 3 (After adjustment) and also reference Rep.Gr - 44 Lane change assist control units (J769 and J770) - To remove and fit
