## Technical product information

| <b>Topic</b> | New Continental GT, GTC, New Flying Spur - Blind spot monitors not functional DTC C1114F3 logged in address 003C or 00CF |
| <b>Transaction No.</b> | 2062884/2 |

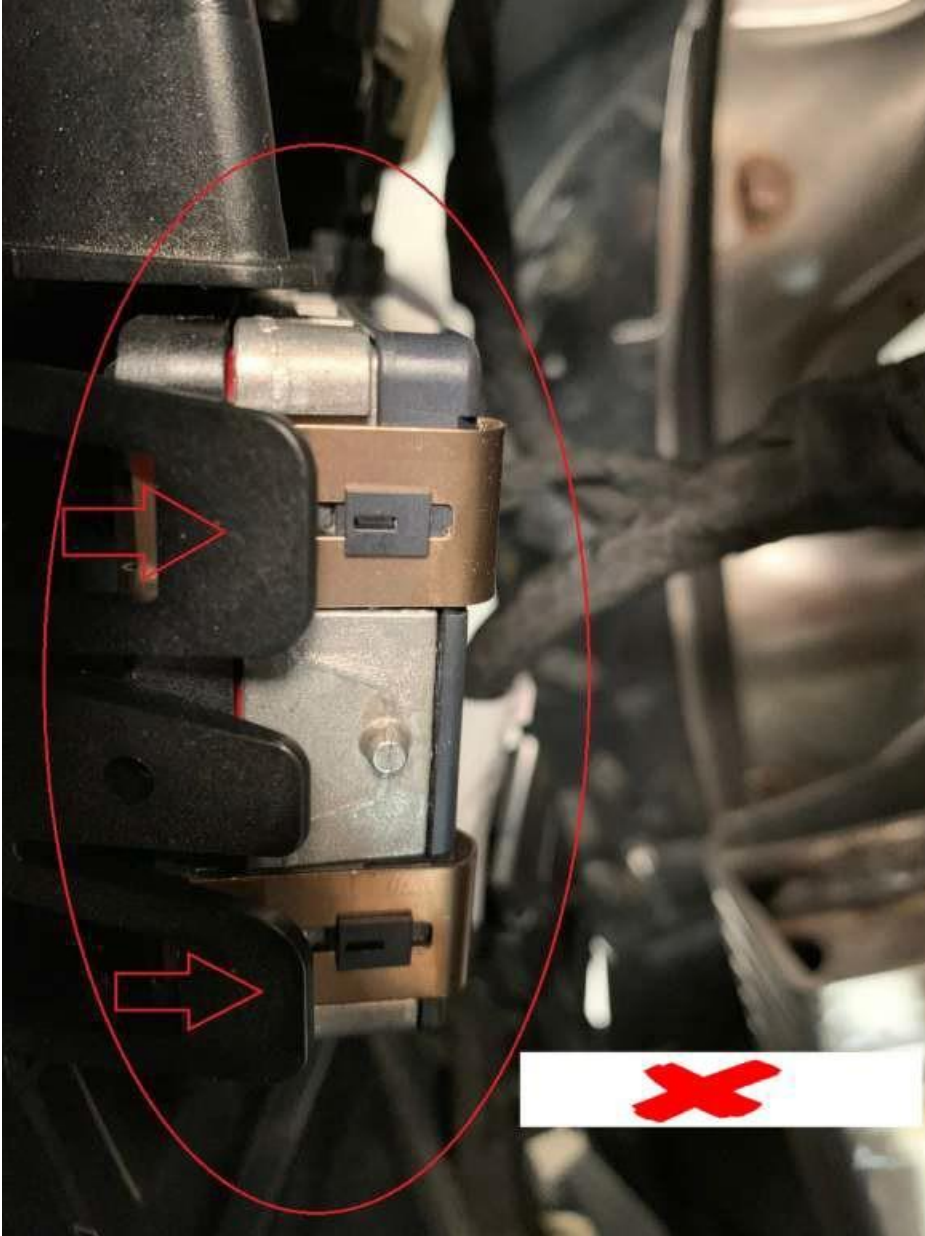
Figure 2

Master or slave rear radars are not fitted correctly (unclipped or poorly installed)

3) In the event one or both control units are loose/detached - Refer to Figures 2 (Before adjustment) and 3 (After adjustment) and also reference Rep.Gr - 44 Lane change assist control units (J769 and J770) - To remove and fit
