# SERVICE CAMPAIGN BULLETIN

| BR21-002 | NTB21-030 | April 15, 2021 |

## VOLUNTARY SERVICE CAMPAIGN ABS/VDC REPROGRAMMING

**CAMPAIGN ID #:** P1A01  
**APPLIED VEHICLES:** 2021 Rogue (T33)

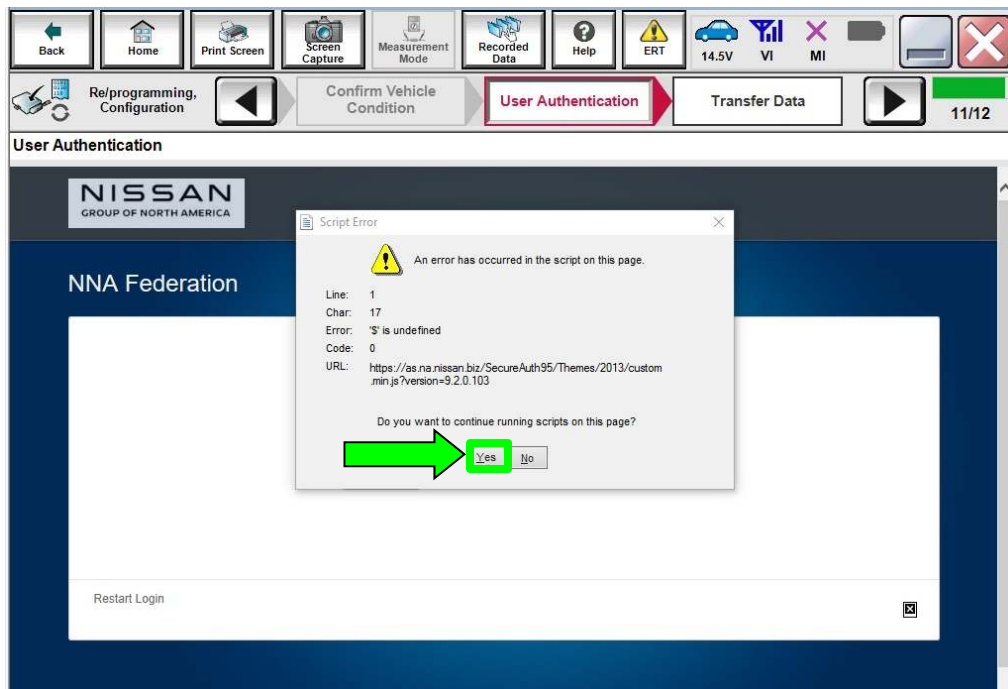
24. If the Script Error message in Figure 18 is shown, Select **Yes**.

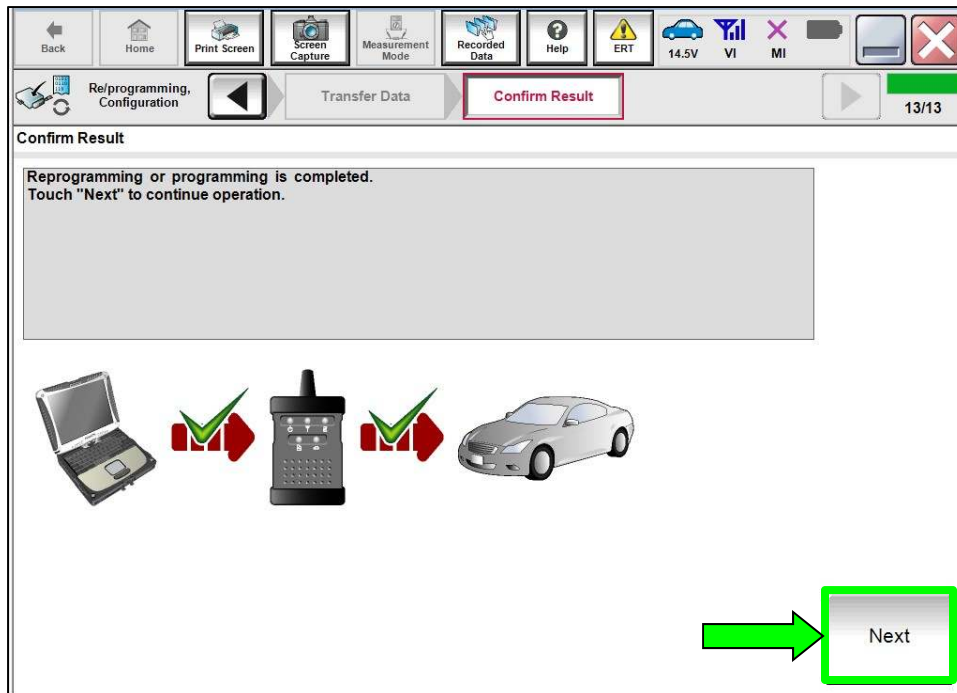
27. If the screen in Figure 21 displays, reprogramming is complete. Select **Next** and skip to step 28 on page 16. If the screen in Figure 21 does not display (indicating that reprogramming did not complete), refer to the information on the next page.

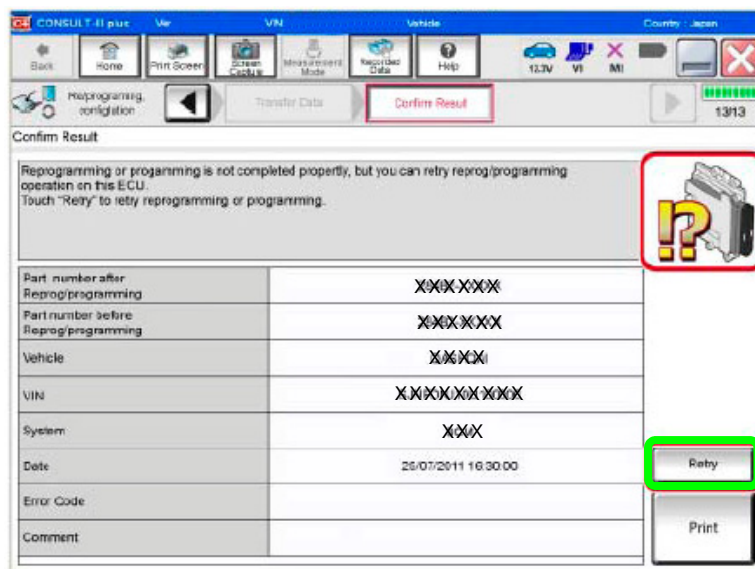
Figure 22

**If reprogramming does not complete and the “!” icon displays as shown in Figure 22:**

- Check battery voltage (12.0 V – 15.5 V).
- Ignition is ON, engine is OFF.
- External Bluetooth® devices are OFF.
- All electrical loads are OFF.
- Select retry and follow the on screen instructions.
- “Retry” may not go through on first attempt and can be selected more than once.

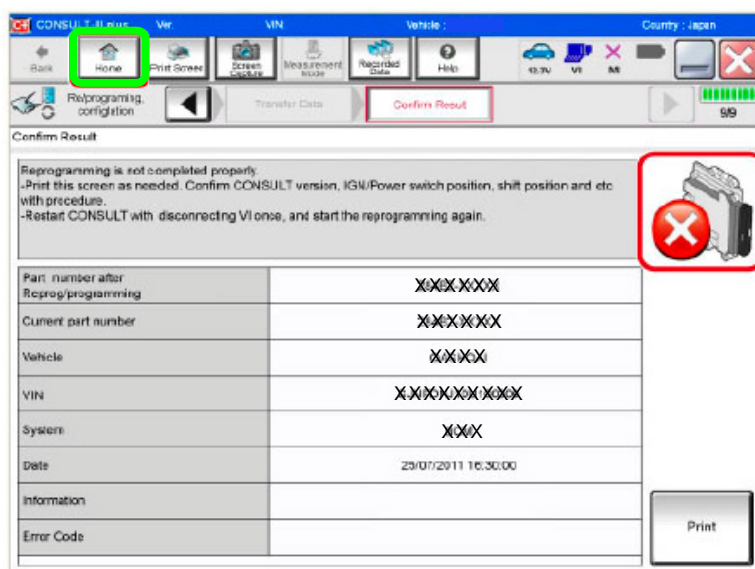
Figure 23

**If reprogramming does not complete and the “X” icon displays as shown in Figure 23:**

- Check battery voltage (12.0 V – 15.5 V).
- CONSULT A/C adapter is plugged in.
- Ignition is ON, engine is OFF.
- Transmission is in Park.
- All C-III plus / VI cables are securely connected.
- All C-III plus updates are installed.
- Select Home, and restart the reprogram procedure from the beginning.
