## SERVICE BULLETIN

EC12-030

October 29, 2012

### 2012 VERSA SEDAN; MIL ON WITH DTC P0300-P0304

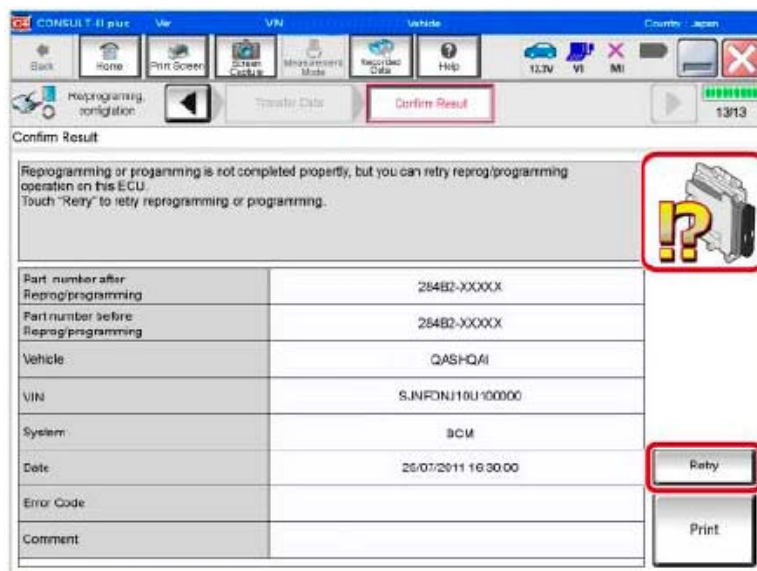
Figure 5

If reprogramming does not complete and the “!” icon displays as shown in Figure 5:

- Check battery voltage (12.0–15.5 V).
- Ignition is ON, engine OFF.
- External Bluetooth® devices are OFF.
- All electrical loads are OFF.
- **Select retry and follow the on screen instructions.**
- “Retry” may not go through on first attempt and can be selected more than once.

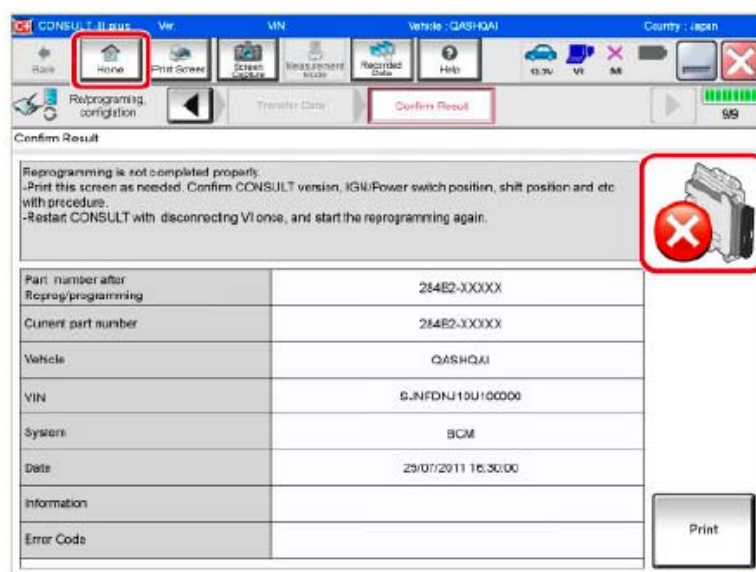
Figure 6

If reprogramming does not complete and the “X” icon displays as shown in Figure 6:

- Check battery voltage (12.0 – 15.5 V).
- CONSULT A/C adapter is plugged in.
- Ignition is ON, engine OFF.
- Transmission is in Park.
- All C-III plus / VI cables are securely connected.
- All C-III plus updates are installed.
- **Select Home, and restart the reprogram procedure from the beginning.**
