EC12-033

December 21, 2012

## 2012 QX56; MIL ON WITH DTC P008B STORED

APPLIED VEHICLE: 2012 QX56 (Z62)

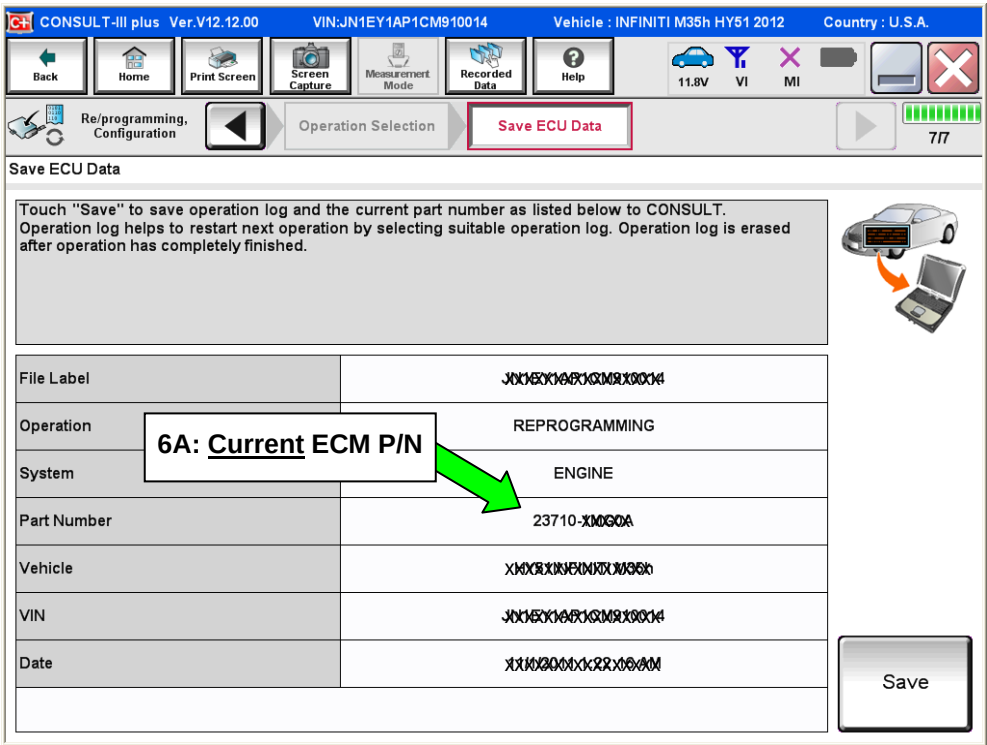
Figure 2

6. When you get to the screen shown in Figure 2, confirm this bulletin applies as follows.

A. Find the ECM Part Number and write it on the repair order.

NOTE: This is the current ECM Part Number (P/N).

B. Compare the P/N you wrote down to the numbers in the Current ECM Part Number column in Table A below.

- If there is a match, this bulletin applies. Continue with the reprogramming procedure.
- If there is not a match, this bulletin does not apply. Close C-III plus and refer to ASIST for further diagnostic information.

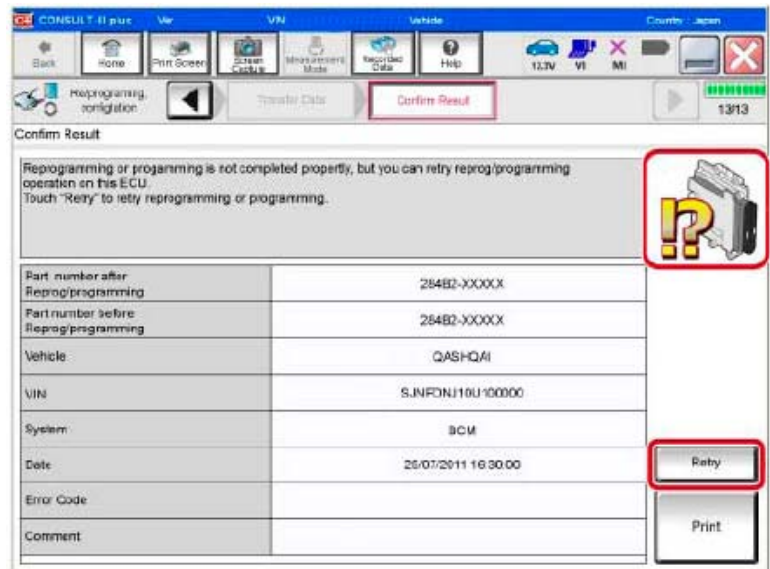
Figure 5

If reprogramming does not complete and the “!?” icon displays as shown in Figure 5:

- Check battery voltage (12.0 - 15.5 V).
- Ignition is ON, engine OFF.
- External Bluetooth® devices are OFF.
- All electrical loads are OFF.
- Select retry and follow the on screen instructions.
- “Retry” may not go through on first attempt and can be selected more than once.

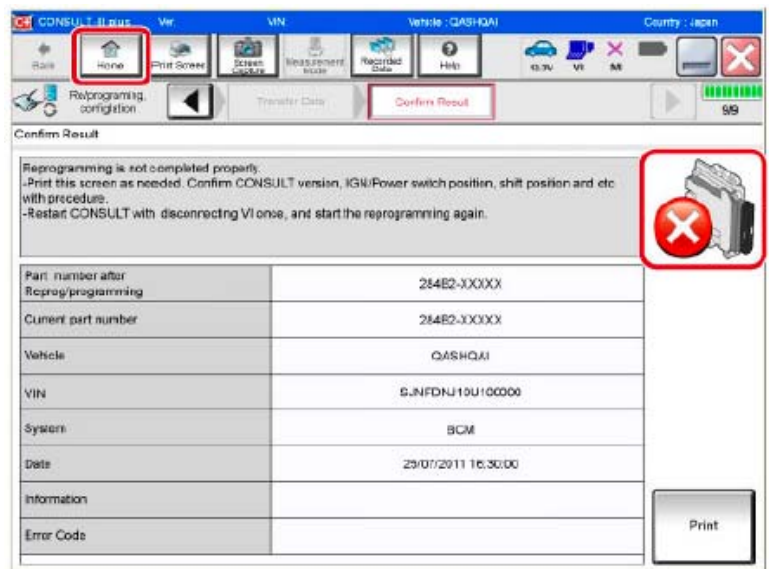
Figure 6

If reprogramming does not complete and the “X” icon displays as shown in Figure 6:

- Check battery voltage (12.0 - 15.5 V).
- CONSULT A/C adapter is plugged in.
- Ignition is ON, engine OFF.
- Transmission is in Park.
- All C-III plus / VI cables are securely connected.
- All C-III plus updates are installed.
- Select Home, and restart the reprogram procedure from the beginning.
