# SERVICE CAMPAIGN BULLETIN

NTB12-065b

## VOLUNTARY SERVICE CAMPAIGN 2013 ALTIMA METER BACK LIGHT ILLUMINATION

**APPLIED VEHICLE:** 2013 Altima (L33)

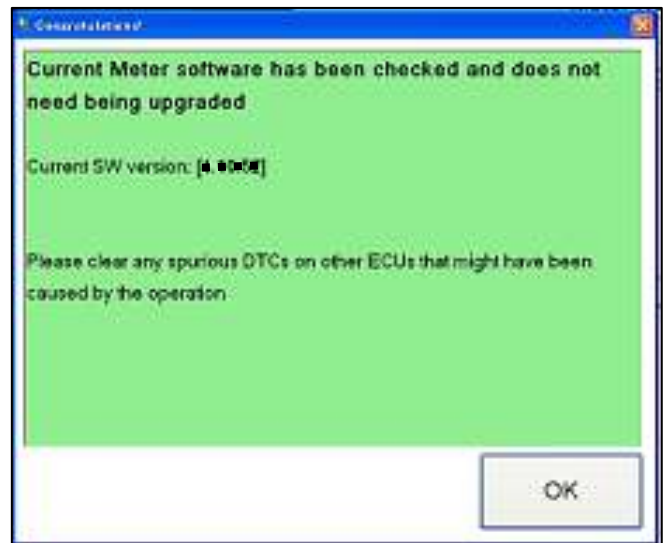
**NOTE:** If the screen in Figure 4 displays, reprogramming is not needed for this vehicle or it has already been done:

- a. Select OK.
- b. Close the reprogramming tool/software.
- c. Skip to step 16.

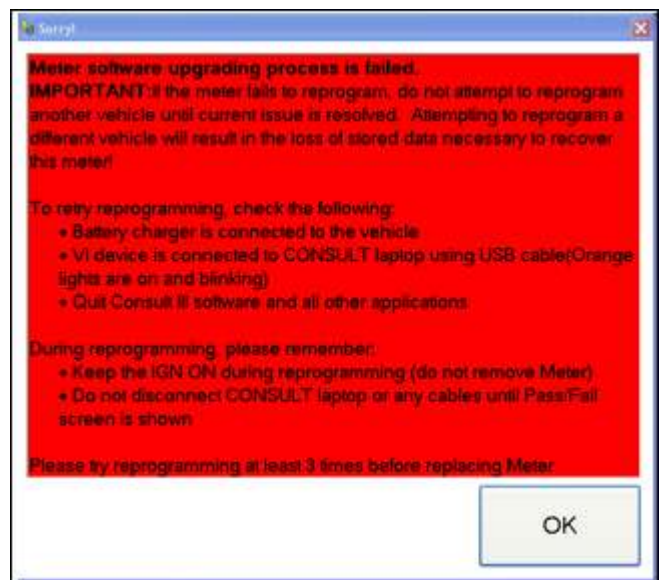
**NOTE:** If the screen in Figure 5 displays:

**IMPORTANT:** If you get the screen in Figure 5 above:

**Try reprogramming at least 3 more times.**

- a. Select OK and close the reprogramming tool/software.
- b. Restart this Service Procedure from the beginning.
  - **Make sure all steps are completed correctly.**
  - CONSULT software and all other applications are closed.
  - Plus VI is securely connected to the vehicle and USB cable is connected.
  - Battery charger is connected to the vehicle.

- Make sure to complete all reprogramming attempts on the current vehicle before moving to another vehicle.
- Using the reprogramming tool on another vehicle will erase all data for the current vehicle, and the meter for the current vehicle will not be reprogrammable (recoverable).
