ITB12-053b

January 23, 2013

## VOLUNTARY SERVICE CAMPAIGN 2013 JX35 METER BACK LIGHT ILLUMINATION AND DISTANCE TO EMPTY INACCURACY

APPLIED VEHICLE: 2013 JX35 (L50)

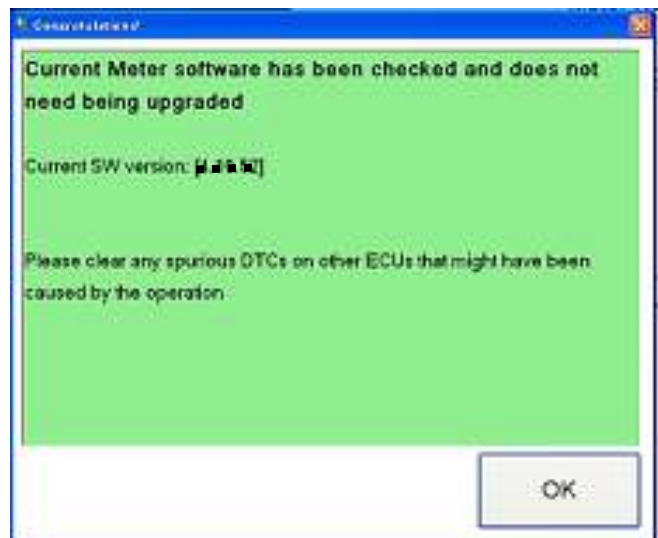
NOTE: If the screen in Figure 4 displays, reprogramming is not needed for this vehicle or it has already been done:

- a. Select OK.
- b. Close the reprogramming tool/software.
- c. Skip to step 16.

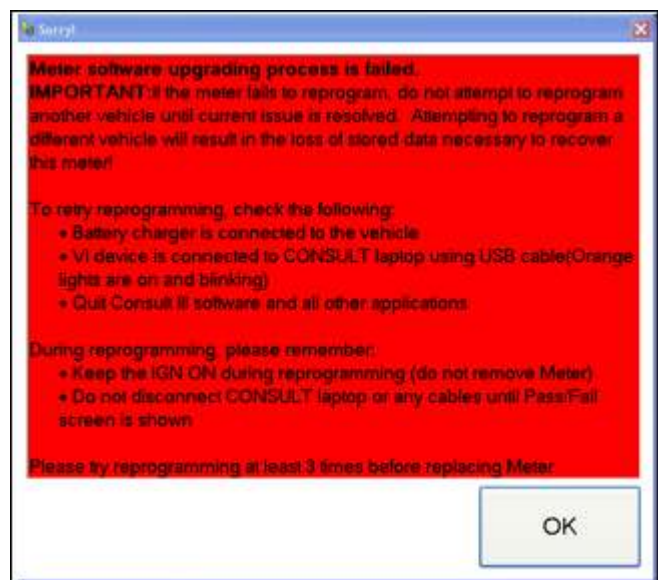
NOTE: If the screen in Figure 5 displays:

IMPORTANT: If you get the screen in Figure 5 above:

- Make sure to complete all reprogramming attempts on the current vehicle before moving to another vehicle.
- Using the reprogramming tool on another vehicle will erase all data for the current vehicle, and the meter for the current vehicle will not be reprogrammable (recoverable).

Try reprogramming at least 3 more times.

- a. Select OK and close the reprogramming tool/software.
- b. Restart this Service Procedure from the beginning.
  - Make sure all steps are completed correctly.
  - CONSULT software and all other applications are closed.
  - Plus VI is securely connected to the vehicle and USB cable is connected.
  - Battery charger is connected to the vehicle.
