EC13-010a

September 17, 2013

## 2012-2013 M HYBRID; MIL "ON" WITH DTC P0300, P0301, P0302, P0303, P0304, P0305, OR P0306 STORED

**APPLIED VEHICLES:** 2012-2013 M35 Hybrid (HY51)

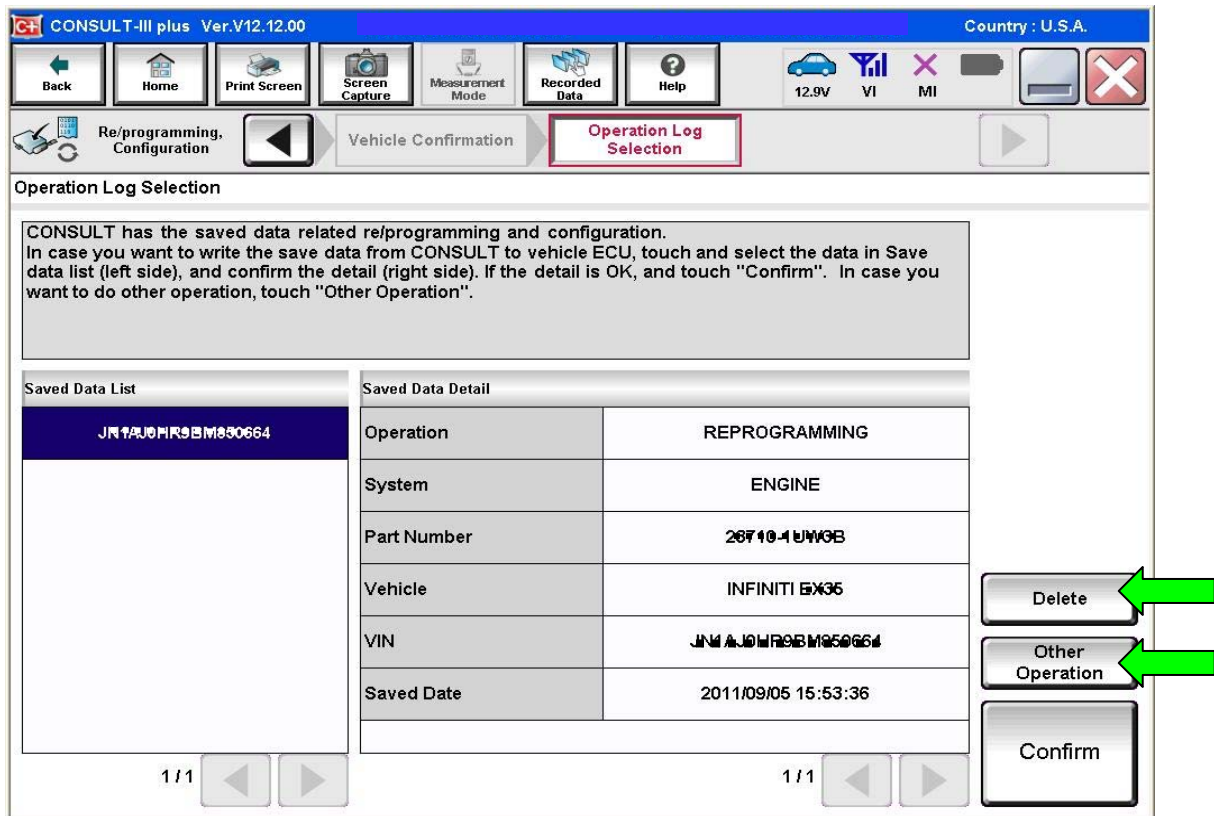
Figure 1a

During the initial "Reprogramming Confirmation" set-up, if you get this screen (Figure 1a):

1. Select Delete.
2. Select Other Operation.
3. Continue with the reprogramming procedure.

NOTE: If reprogramming does not complete, this screen can display for reprogramming recovery. Do not select Delete if this screen displays during reprogram recovery.

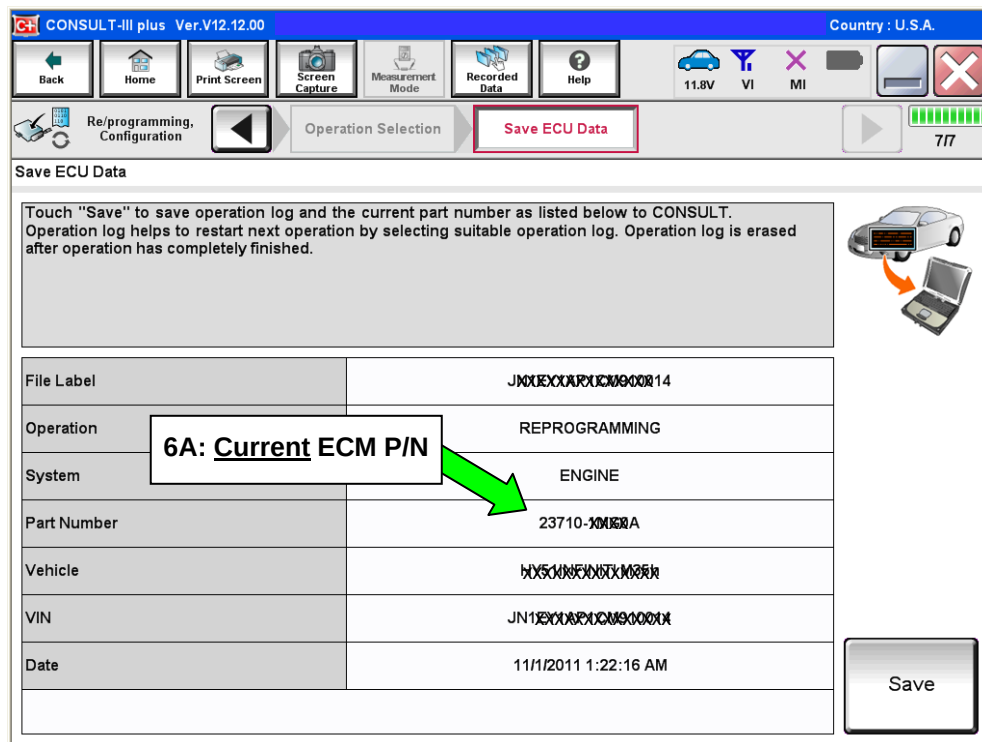
Figure 2

6. When you get to the screen shown in Figure 2, confirm this bulletin applies as follows.

A. Find the ECM Part Number and write it on the repair order.

NOTE: This is the current ECM Part Number (P/N).

B. Compare the P/N you wrote down to the numbers in the Current ECM Part Number column in Table A below.

- If there is a match, this bulletin applies. Continue with the reprogramming procedure.
- If there is not a match, this bulletin does not apply. Close C-III plus and refer to ASIST for further diagnostic information.

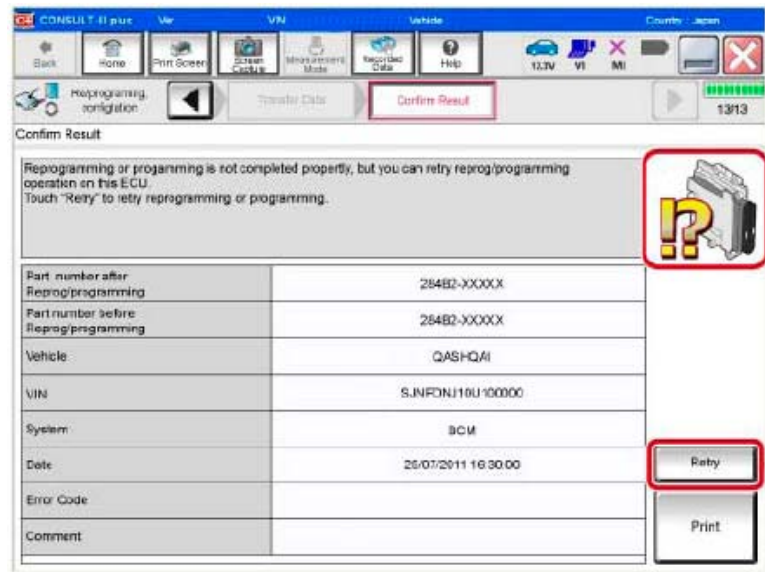
Figure 5

If reprogramming does not complete and the “!?” icon displays as shown in Figure 5:

- Check battery voltage (12.0 -15.5 V).
- Ignition is ON, engine OFF.
- External Bluetooth® devices are OFF.
- All electrical loads are OFF.
- Select retry and follow the on screen instructions.
- “Retry” may not go through on first attempt and can be selected more than once.

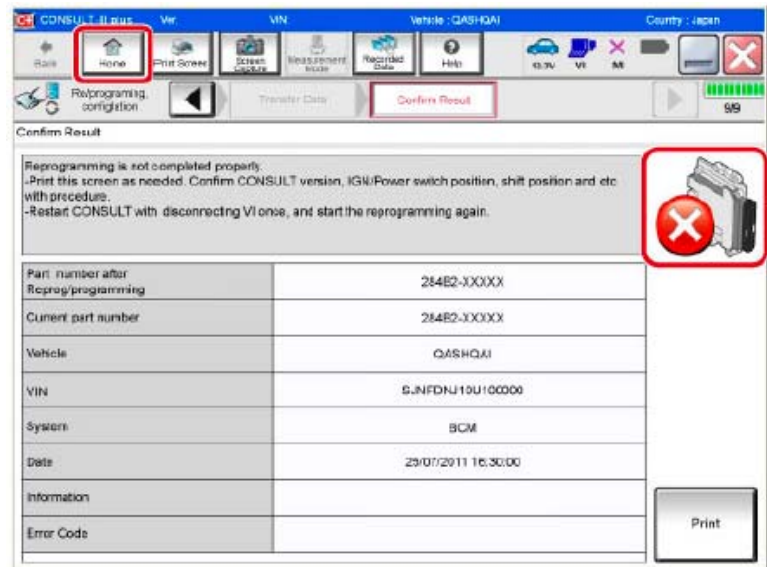
Figure 6

If reprogramming does not complete and the “X” icon displays as shown in Figure 6:

- Check battery voltage (12.0 -15.5 V).
- CONSULT A/C adapter is plugged in.
- Ignition is ON, engine OFF.
- Transmission is in Park.
- All C-III plus / VI cables are securely connected.
- All C-III plus updates are installed.
- Select Home, and restart the reprogram procedure from the beginning.
