## SERVICE BULLETIN

AT10-009c

November 5, 2013

### 2010 MAXIMA, MURANO, & V-6 ALTIMA; MIL IS ON AND / OR SLOWER-THAN-NORMAL ACCELERATION

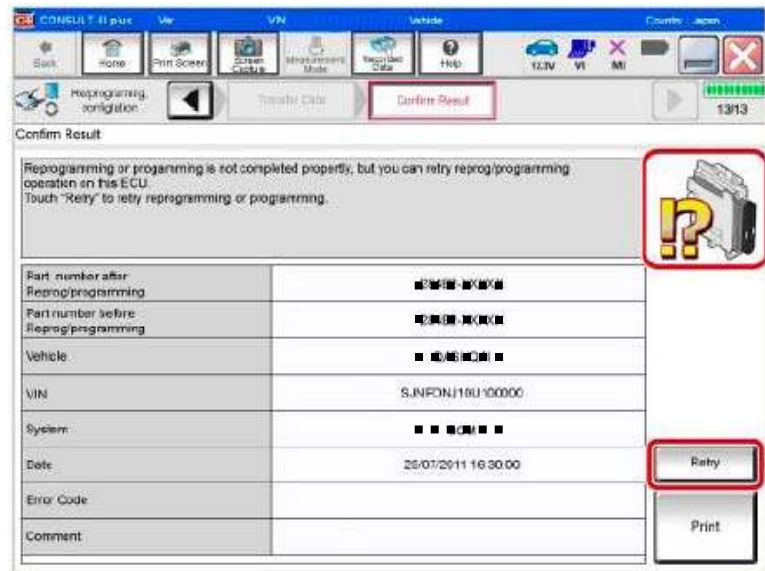
Figure 17

If reprogramming does not complete and the “!?” icon displays as shown in Figure 17:

- Check battery voltage (12.0–15.5 V).
- Ignition is ON, engine OFF.
- External Bluetooth® devices are OFF.
- All electrical loads are OFF.
- **Select retry and follow the on screen instructions.**
- **“Retry” may not go through on first attempt and can be selected more than once.**

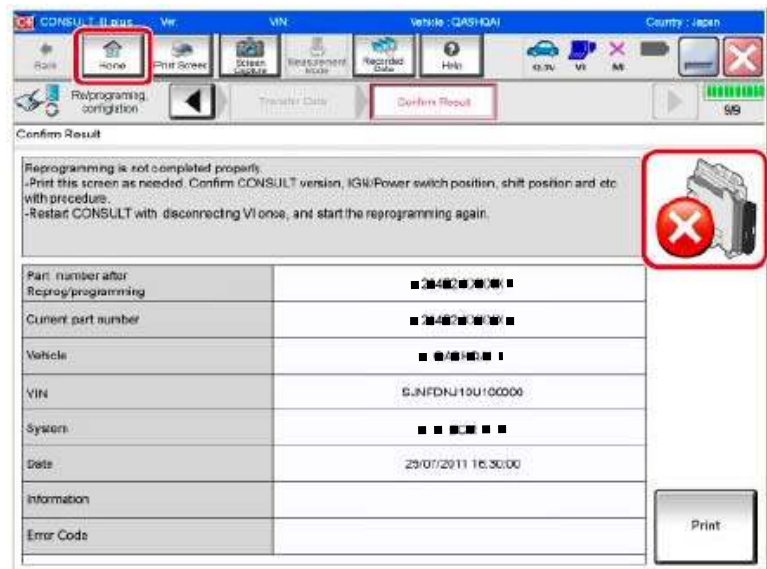
Figure 18

If reprogramming does not complete and the “X” icon displays as shown in Figure 18:

- Check battery voltage (12.0 – 15.5 V).
- CONSULT A/C adapter is plugged in.
- Ignition is ON, engine OFF.
- Transmission is in Park.
- All C-III plus / VI cables are securely connected.
- All C-III plus updates are installed.
- **Select Home, and restart the reprogram procedure from the beginning.**
